**ARMOUR BRANCH REPORT  
ON**

Comprehensive Firing Trials  
against  
German Panther Pz.Kw.V.

A.T. No. 232.

Project Nos. M. 6815A/4.  
Sheets 1-6.Subject.

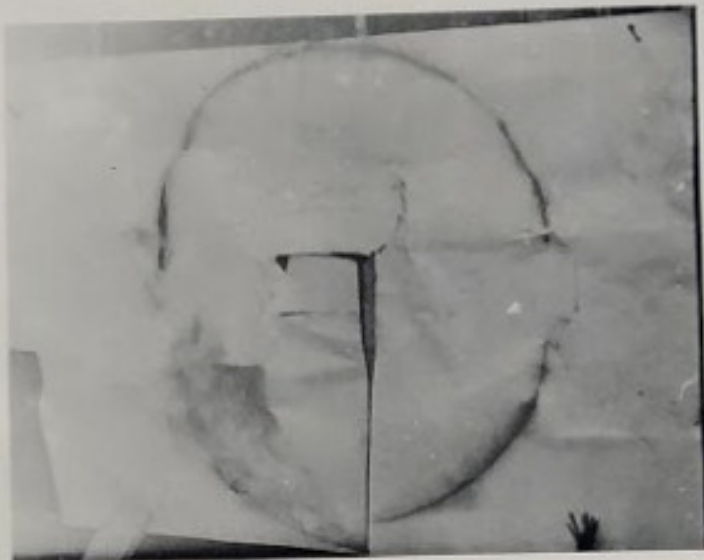
Print No.4.

Item No.4.  
.303" Ball attack at normal against turret escape door, showing condition of witness card fitted behind door.

Note:-  
Splash entered freely, tearing and marking card.

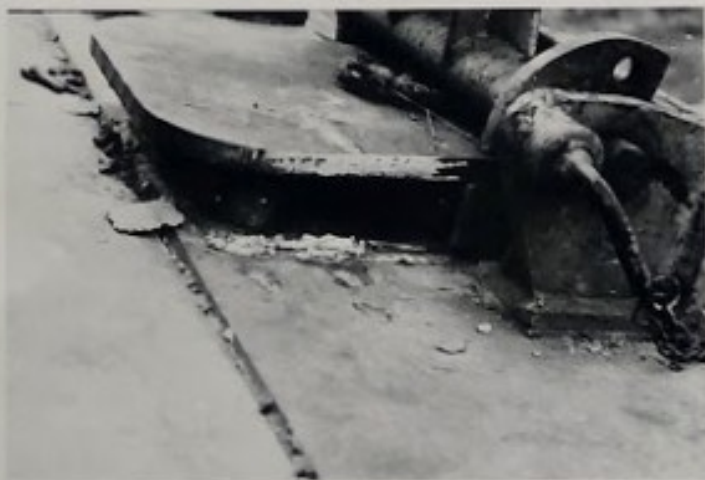
Print No.5.

Item No.10.  
Showing .303" Ball attack against hull fan cowl. Four rounds effective, no splash entry.

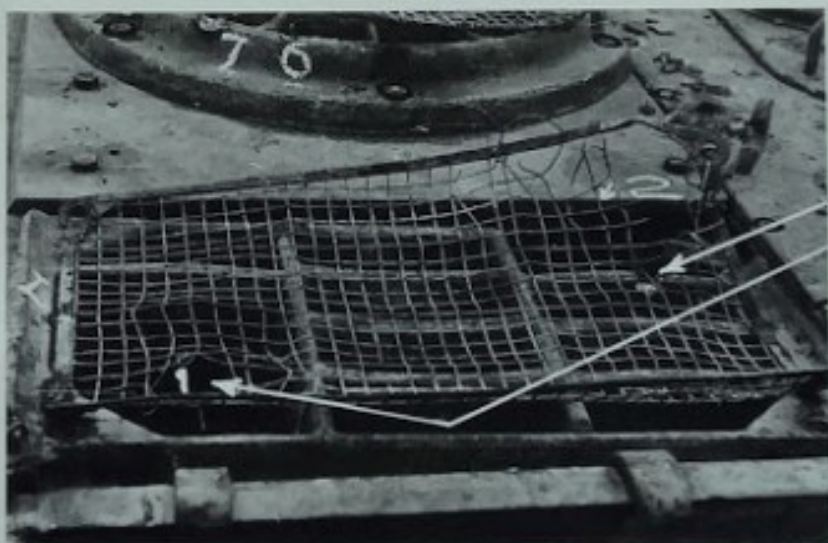
Print No. 14.

Showing damage to rear left-hand inlet louvre caused by Rounds 1 and 2 - 20 mm. Hispano A.P.

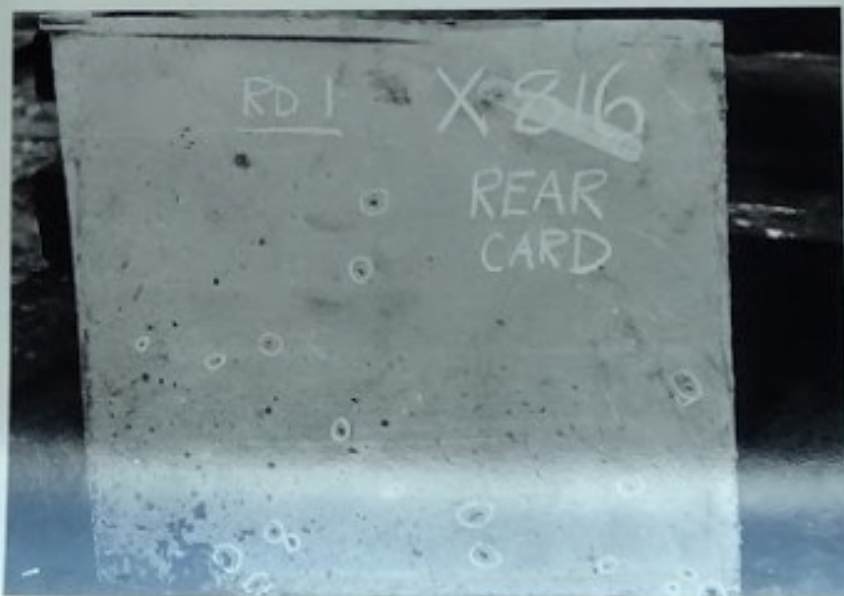
Print No. 15.

Round 1 striking this grille sheared away two transverse cross bars. Extensive perforation of the witness card representing the rear radiator resulted. Considerable water loss would have been caused with ultimate engine stoppage.

Showing condition of rear left-hand witness card representing radiator after Round 1.

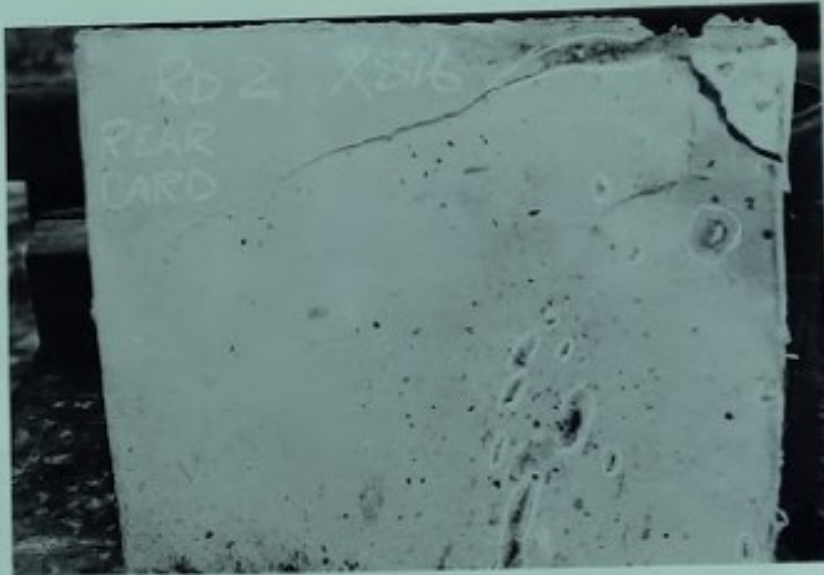
Print No. 16.

Round 2 striking the same grille caused extensive perforation of the witness cards representing the forward and rear radiators. In the case of the forward card it is thought that with the fan in position damage may not have resulted. The results from this round would have been similar to those from round 1.

Showing condition  
of rear left-hand  
witness card  
representing  
radiator after  
Round 2.

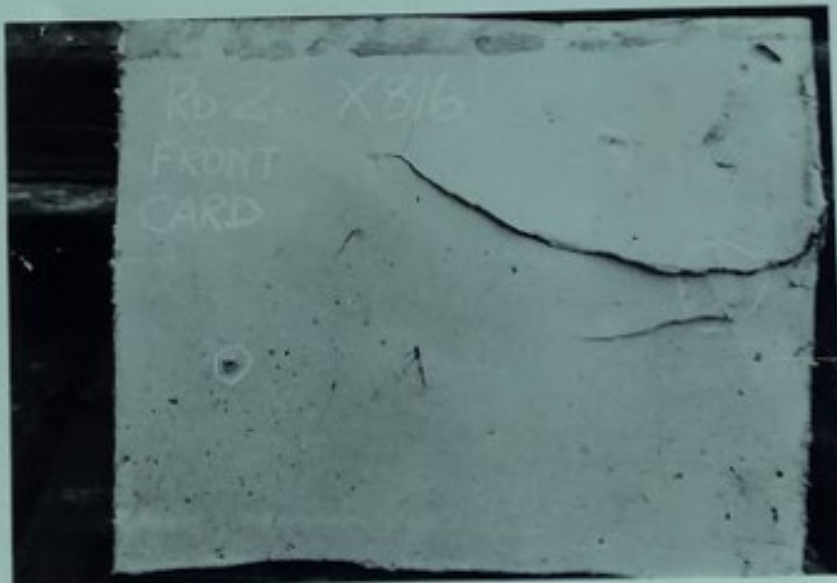
Print No. 17.

Showing condition  
of front left-hand  
witness card  
representing  
radiator after  
Round 2.

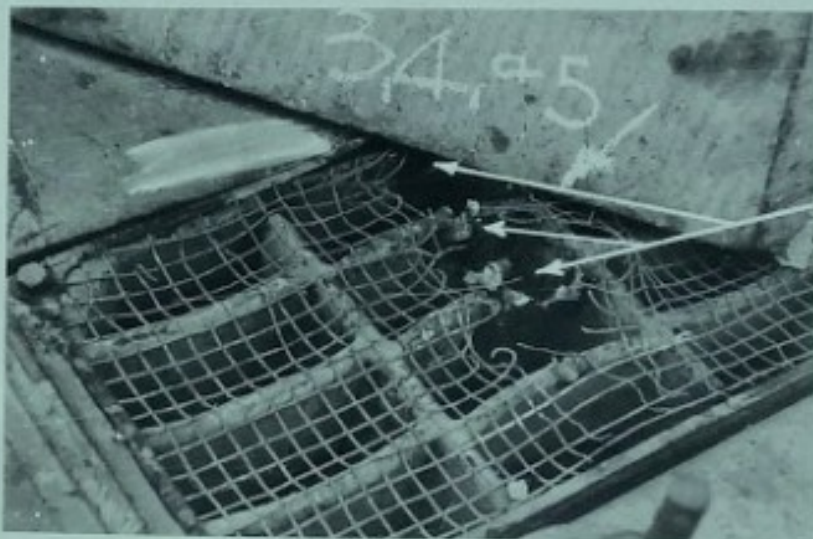
Print No. 18.

Showing damage to forward left-hand louvre caused by Rounds 3, 4, and 5 20 mm. Hispano A. P.

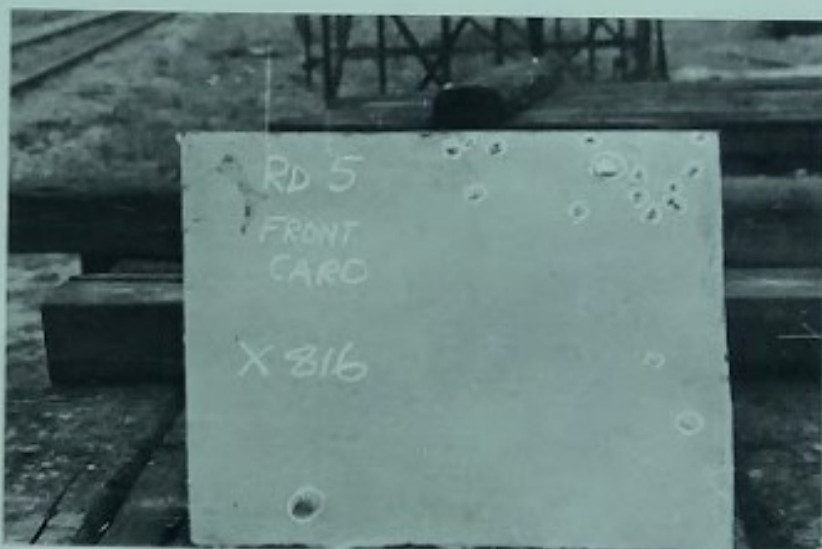
Print No. 19.

Round 5 striking this grille, sheared out metal and caused extensive perforation of the rear card. This damage was comparable to that caused by attack against the rear grille and confirmed the vulnerability of the system.

Showing condition of front left-hand witness card representing radiator after Round 5.

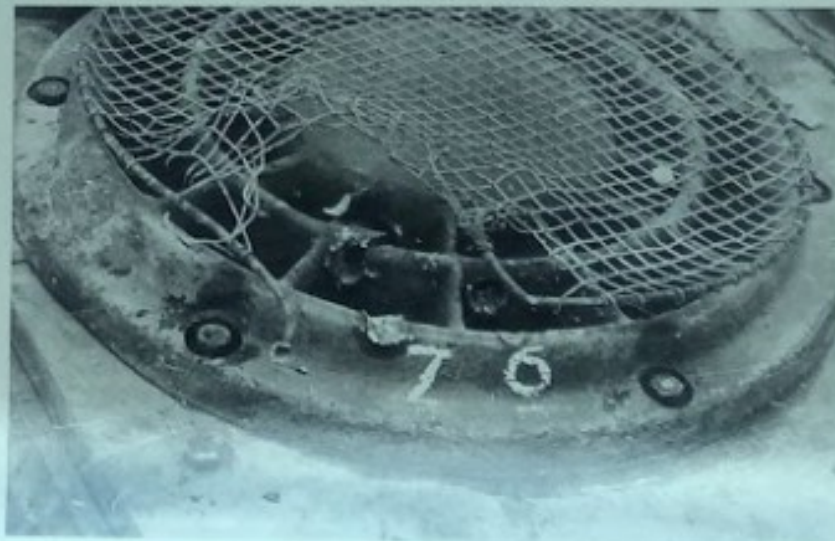
Print No. 20.

Showing damage to left-hand circular outlet louvre caused by Rounds 6 and 7 - 20 mm. Hispano A. P. Witness cards only slightly marked.

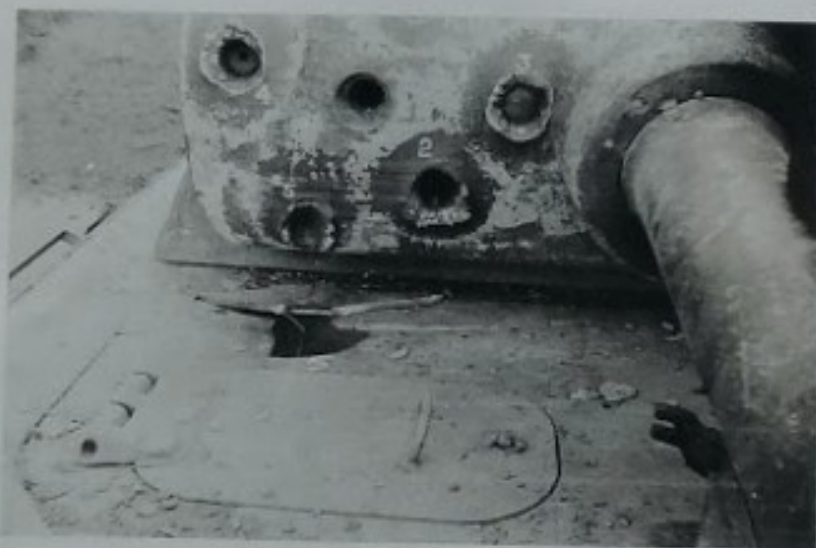
Print No. 2.

Front view of damage caused by Round 5.

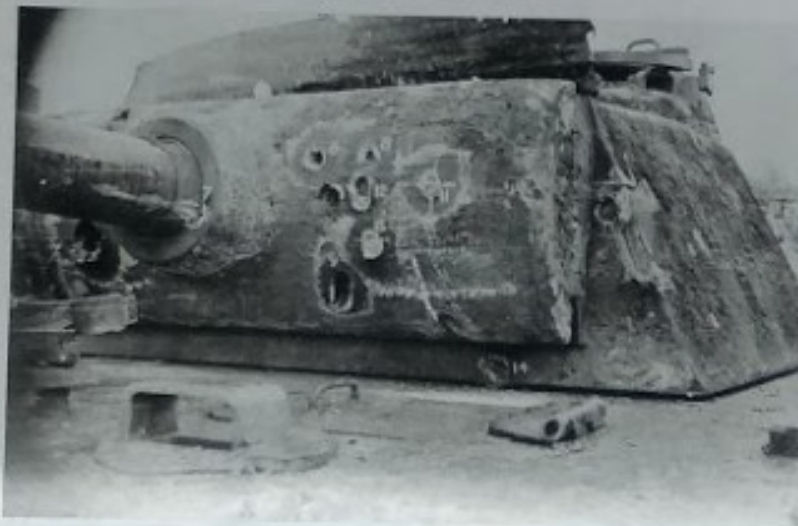
Print No. 3.

Nearside of mantlet after attack by 6 pdr. A. P. D. S., Rounds 6 to 15. Round 7 would have interfered with the recoil of the gun. Round 14 struck the turret below the mantlet, the nose of the shot lodged in roof plate and turret, thus jamming the turret.

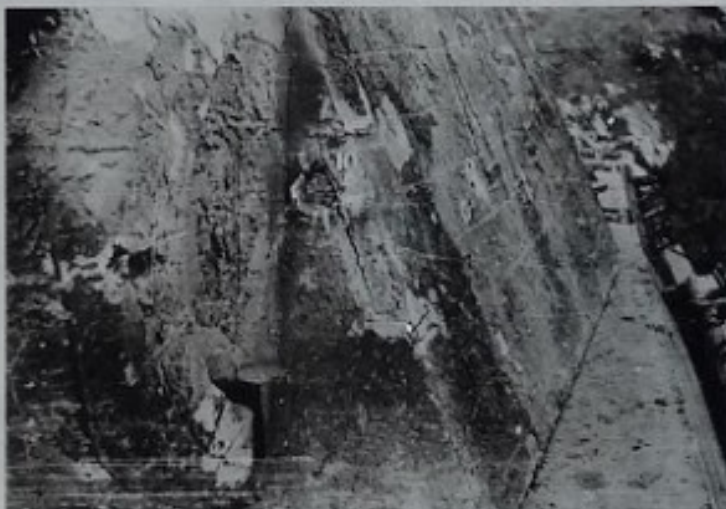
Print No. 4.

Showing damage to interlocking joint between nearside and turret front casting, caused by Round 10, 6 pdr. A.P.D.S., which scooped off the edge of the mantlet.

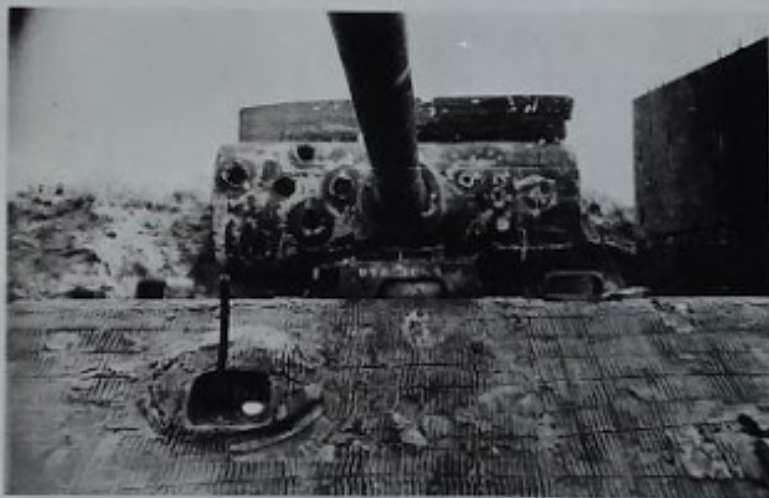
Print No. 5.

General view of mantlet after Rounds 1 to 5, 6 pdr. A.P.C.B.C., and Rounds 6 to 15, 6 pdr. A.P.D.S.

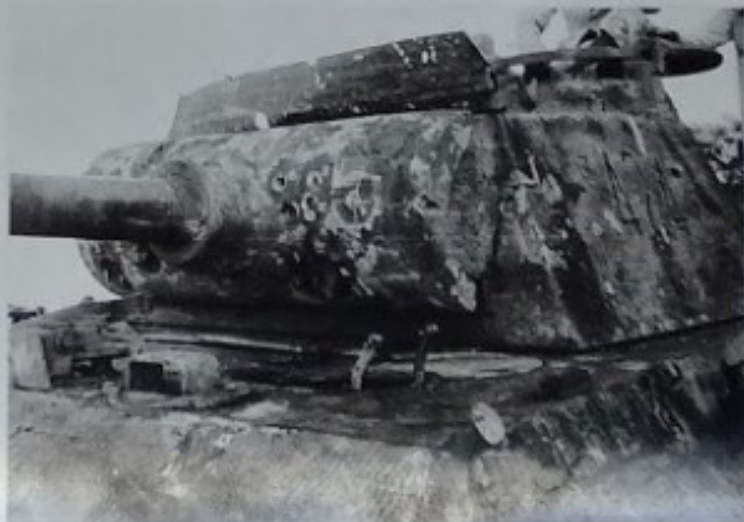
Print No. 6.

Showing damage to roof plate caused by Round 16, 75 mm. A.P.C.B.C. Shell, after scooping off mantlet and penetrating roof.

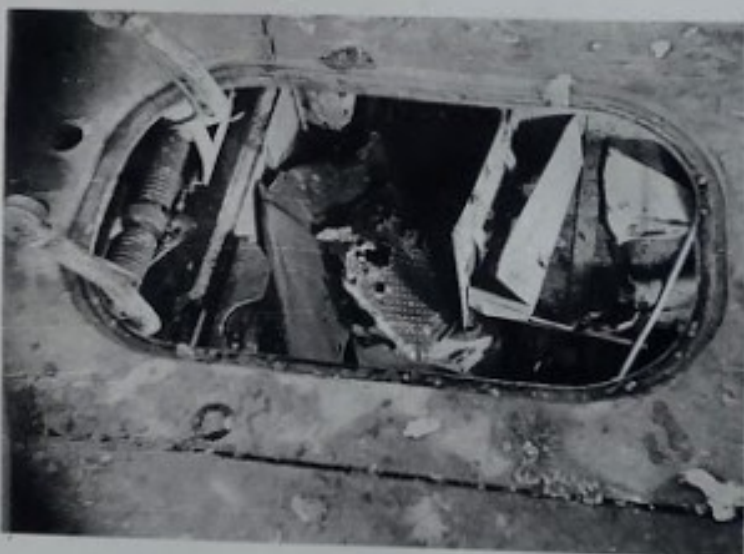
Print No. 8.

Showing damage to ammunition bin behind hull gunner's station after Round 5 had scooped down through roof plate. Similar damage was caused by Round 16 to the ammunition bin behind the driver's position. Cordite fires would probably have occurred in both cases. See also Print No. 7.

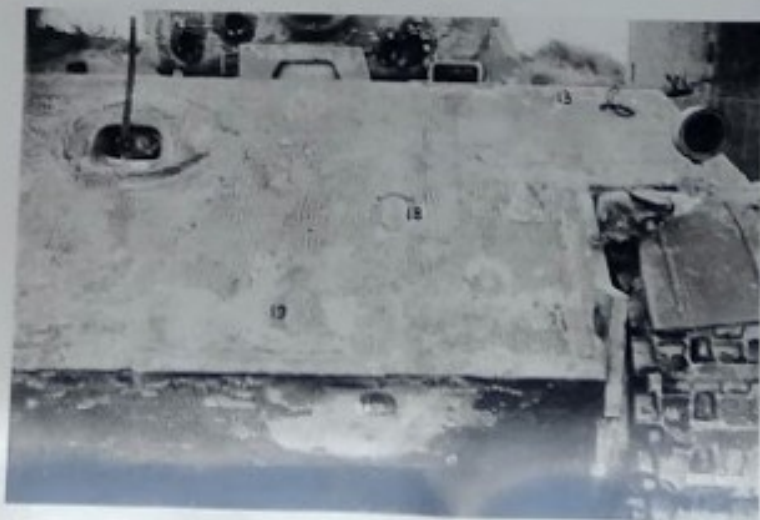
Print No. 9.

Glacis and nose plates after attack by 6 pdr. A.P.D.S., Rounds 17 to 20. Arrows near the front edge indicate the extent of the weld failures.

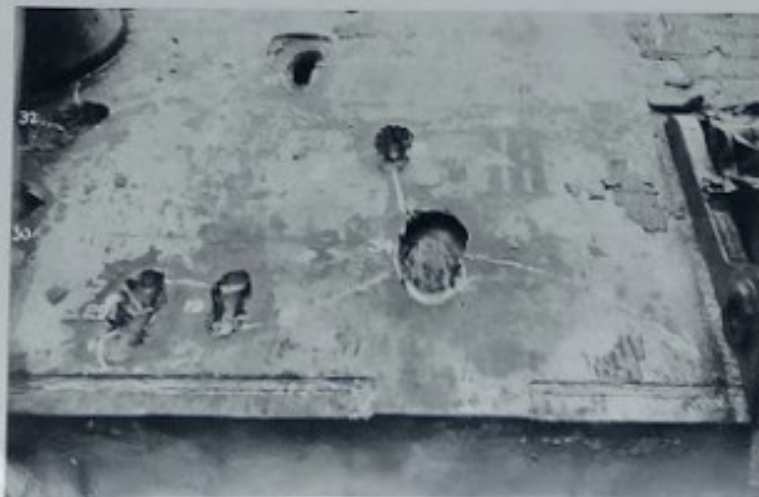
Print No. 12.

Showing point of strike  
of Round 34, 17 pdr.  
A.P.C.B.C.  
The huge flake off the  
rear face of the armour  
was held in position by  
the final drive support  
members. See Print  
No. 13.  
The 17 pdr. attack  
caused excessive  
cracking of the glacis  
plate.

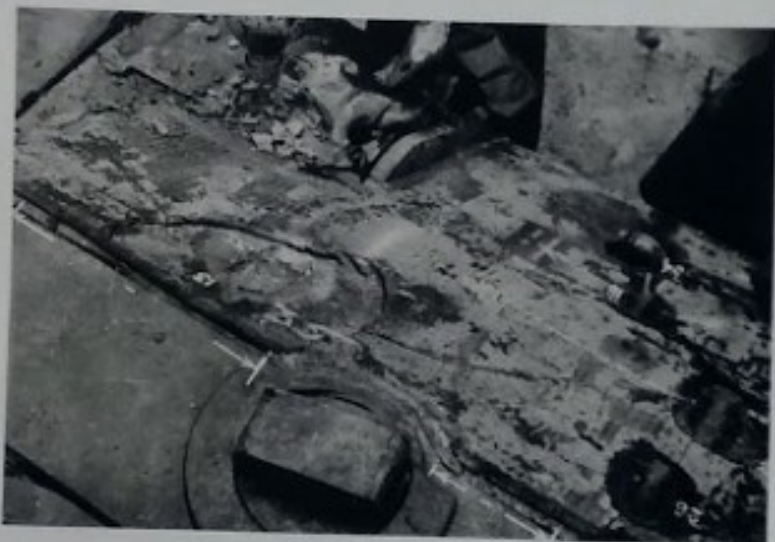
Print No.14.

Round 35, 17 pdr. A.P.C.B.C. at 53°, was practically a double hit on Round 13, 6 pdr. A.P.D.S. Note the extent of the cracks in the glacis plate and the failure of the weld to the roof. In many cases the fractured welds proved to be old junction cracks which opened up progressively during the trial.

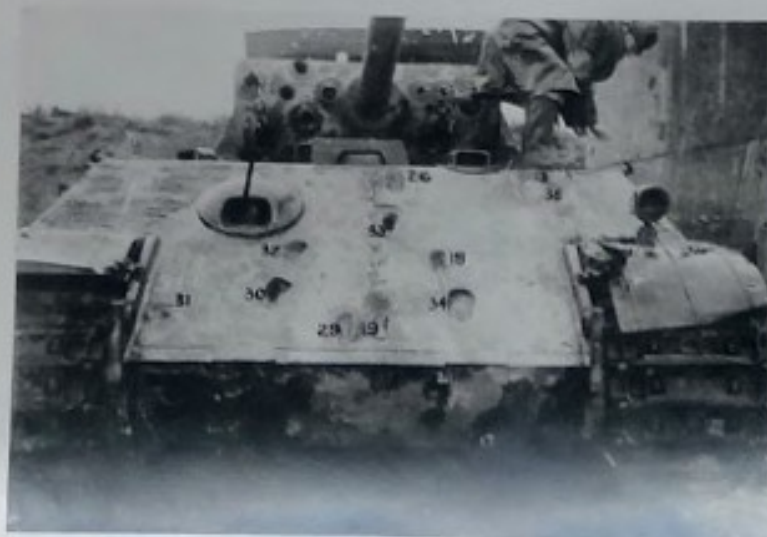
Print No.15.

General view of front of vehicle after attack by 6 pdr. A.P.D.S., Rounds 13, 17 to 20, and 26, 17 pdr. A.P.D.S., Rounds 30 to 33, and 17 pdr. A.P.C.B.C., Rounds 34 and 35.

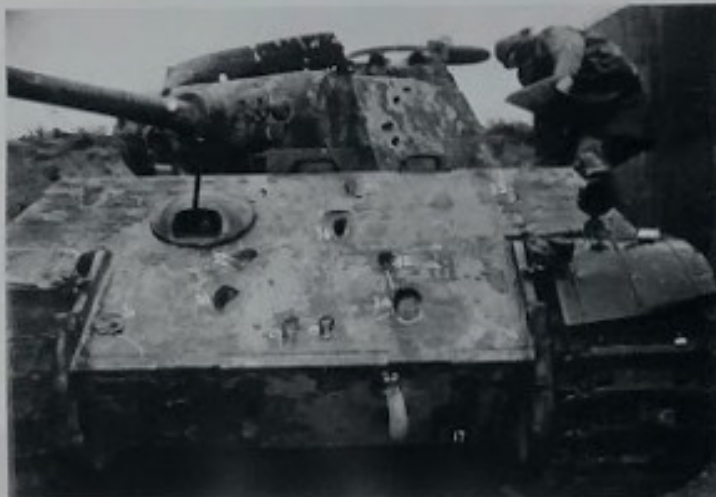
Print No.16.

Showing extensive cracks (lined in white) which developed on the glacis plate. Some of these cracks appeared at points of impact only after the following round had struck the glacis plate.

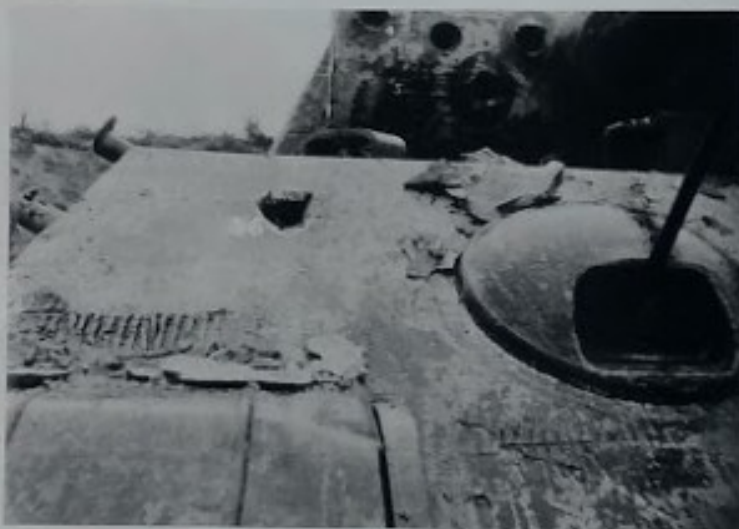
Print No.17.

Round 36, 17 pdr. A.P. at 55°, holed the glacis plate at a velocity equivalent to a range of 900 yds.

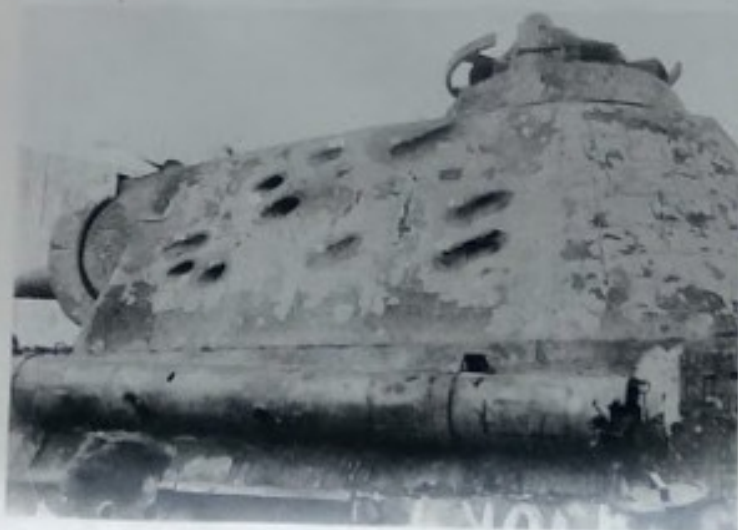
Print No.18.

Nearside wall of turret after attack by 6 pdr. A.P.D.S. at 50°, Rounds 21 and 22, at 60°, Rounds 23 and 28, and from 6 pdr. A.P.C.B.C. at 50°, Rounds 37 to 43. Round 43 holed the turret and passed across the fighting compartment, through the engine compartment bulkhead, and was held in a fuel tank on the offside. An extensive fire was caused.

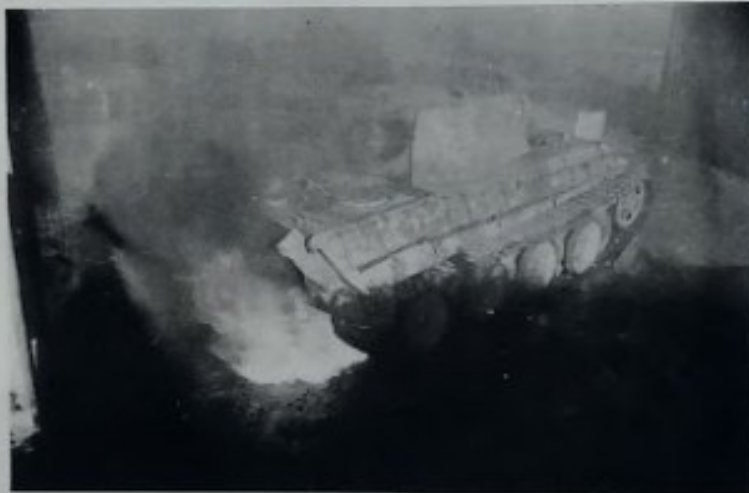
Print No.19.

View of vehicle at commencement of fire caused by Round 43, 6 pdr. A.P.C.B.C. at 50°, against nearside wall of turret.

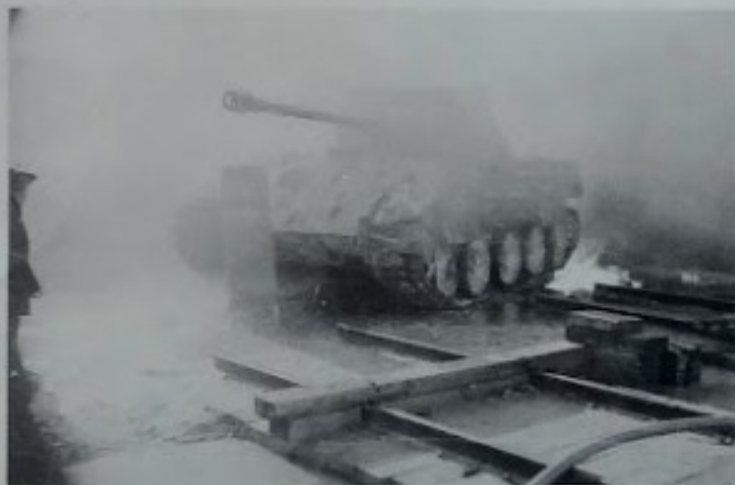
Print No.20.

Front view of vehicle towards end of fire.

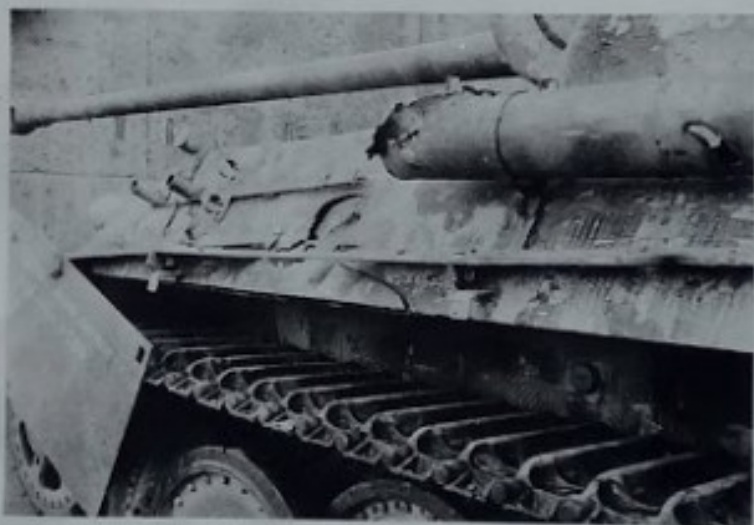
Print No. 23.

View showing extent of  
fracture in pannier  
side from Rounds 44 and  
45.  
The horizontal crack  
measured 40" and the  
vertical one 10".

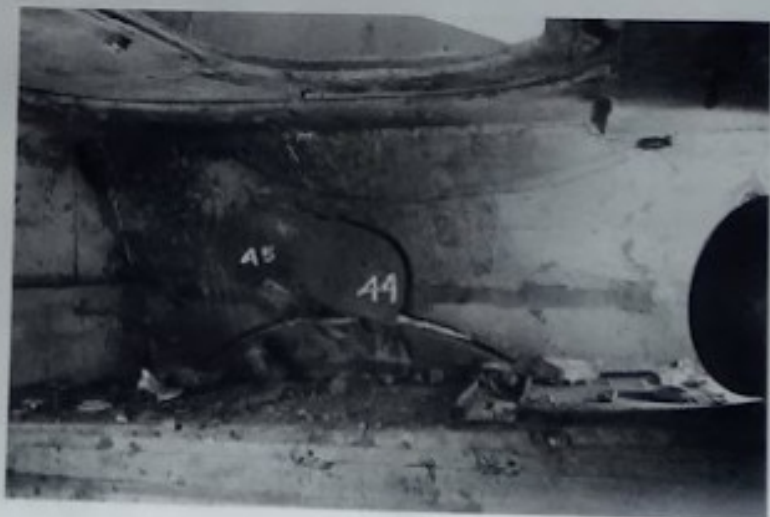
Print No. 24.

Internal face of  
nearside pannier after  
attack by 6 pdr.  
A. P. C. B. C. at 50°,  
Rounds 44 and 45.

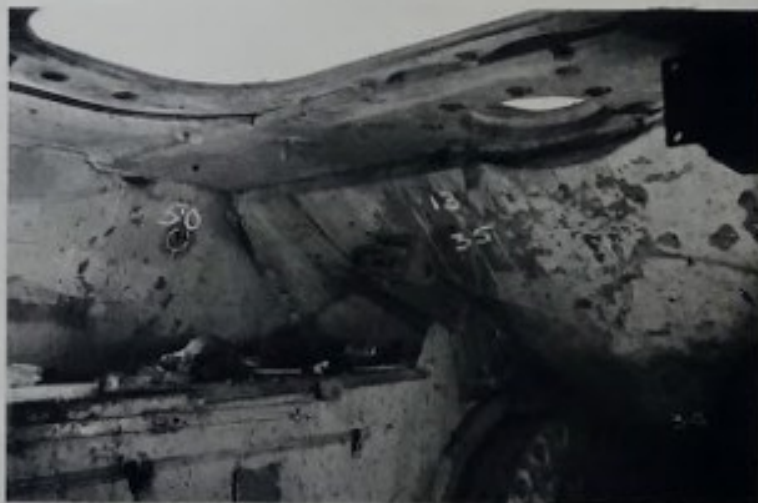
Print No. 28.

Glacis and nearside  
pannier inside faces.  
6 pdr. A.P.D.S., Round  
13.  
17 pdr. A.P.C.B.C.,  
Rounds 34 and 35.  
3-lb. P.I.A.T., Round 50  
Three P.I.A.T. aimed  
at the glacis plate  
failed to detonate.  
(Rounds 51 to 53.)

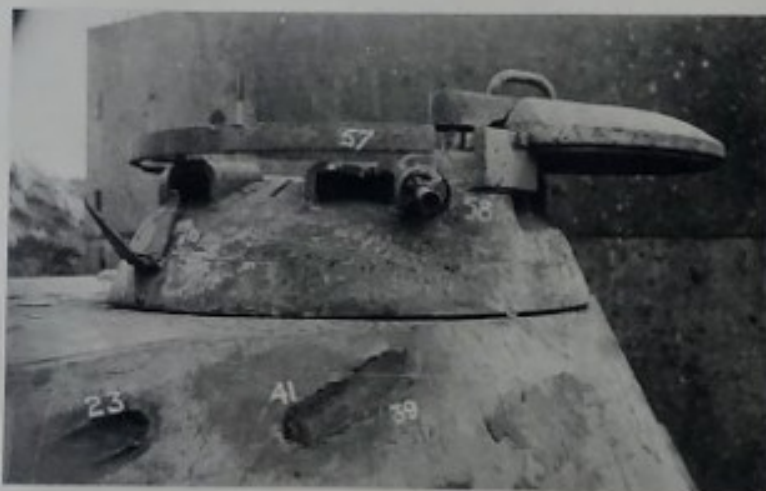
Print No. 29.

Commander's cupola  
after attack by 3-lb.  
P.I.A.T., Rounds 57 and  
58.  
Round 57 struck the top  
edge of the periscope  
protector.  
If periscopes had been  
fitted it is possible  
that fragments would  
not have entered turret,  
unless periscope was  
dislodged.  
Note lodged tail of  
Round 58.

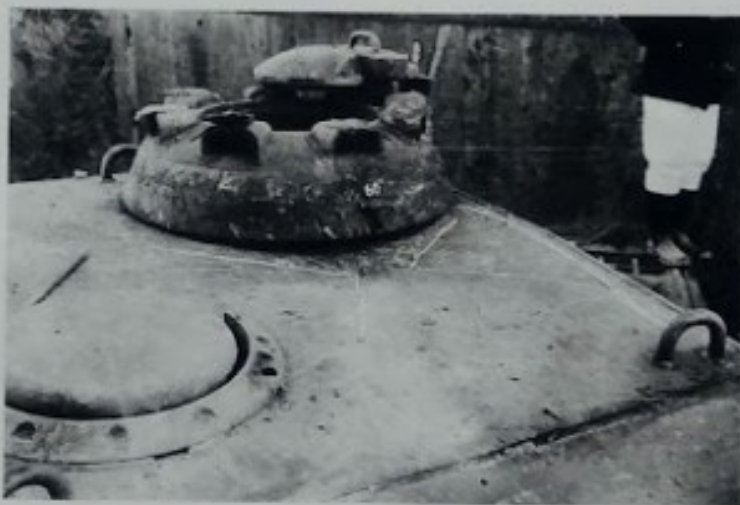
Print No.32.

Cupola after detonation  
of 75 mm. H.E., Round 60.  
Note extensive cracks in  
roof plate.  
Rail guide for machine-  
gun now dislodged.

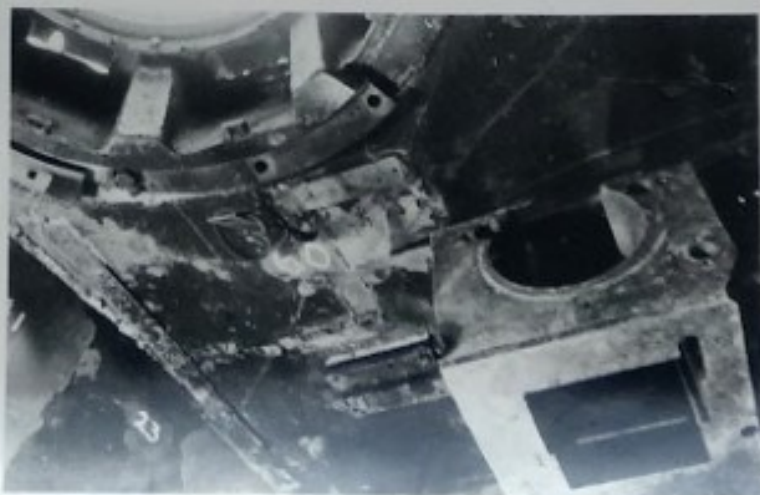
Print No.33.

Inside view of roof  
plate after detonation  
of 75 mm. H.E., Round 60  
on cupola.  
Note bolts dislodged  
from segments holding  
cupola to roof, and  
displacement of welded  
straps.

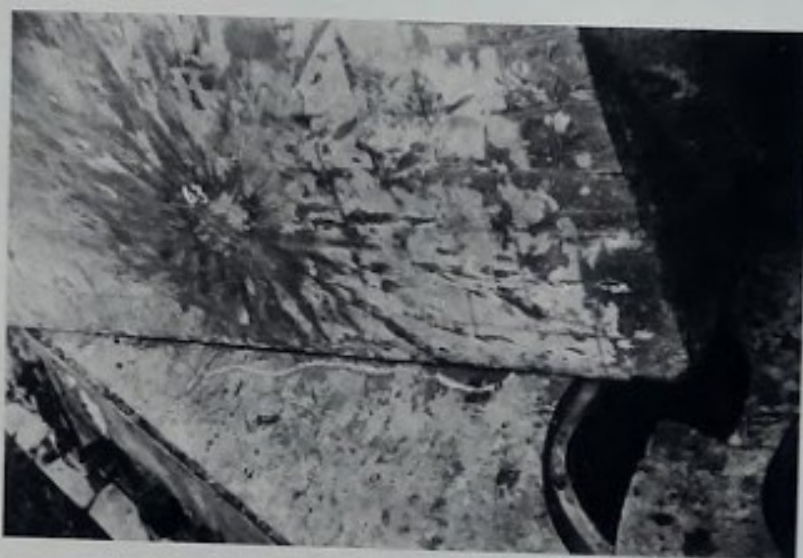
Print No. 35.

Offside wall of turret after detonation of 25 pdr. H.E., Round 63. The roof plate was set down  $\frac{3}{8}$ " below point of impact. The crack extended from the butt joint between the roof plates and ran along the rear of the internal roof stiffener.

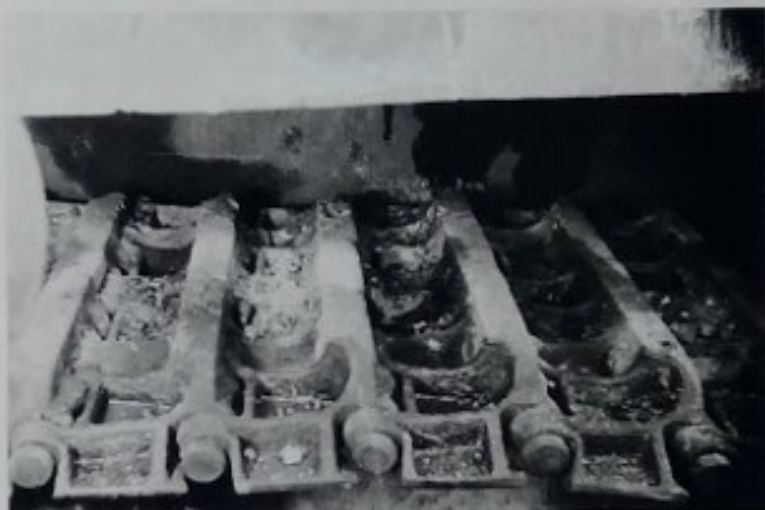
Print No. 37.

Showing damage caused to track by 75 mm. H.E., Round 64, detonating on side armour. Three webs of one link were fractured. See also Print No. 36.

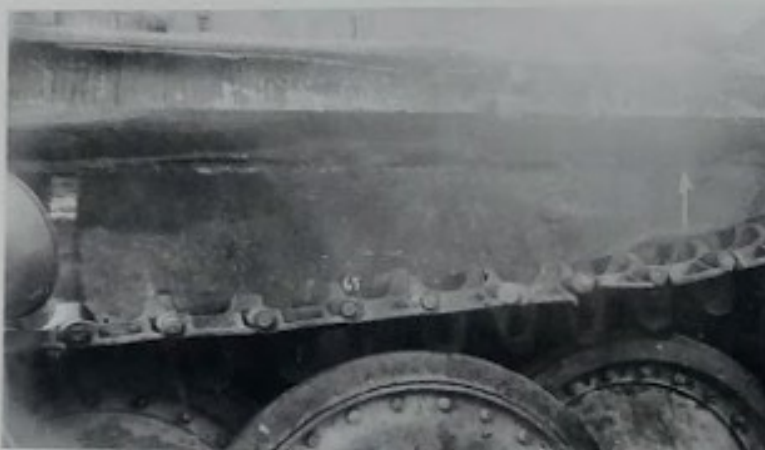
Print No. 38.

Offside lower side armour after detonation of 25 pdr. H.E., Round 65. Weld joint between pannier floor and side armour was fractured for 7'-7" and open 2".

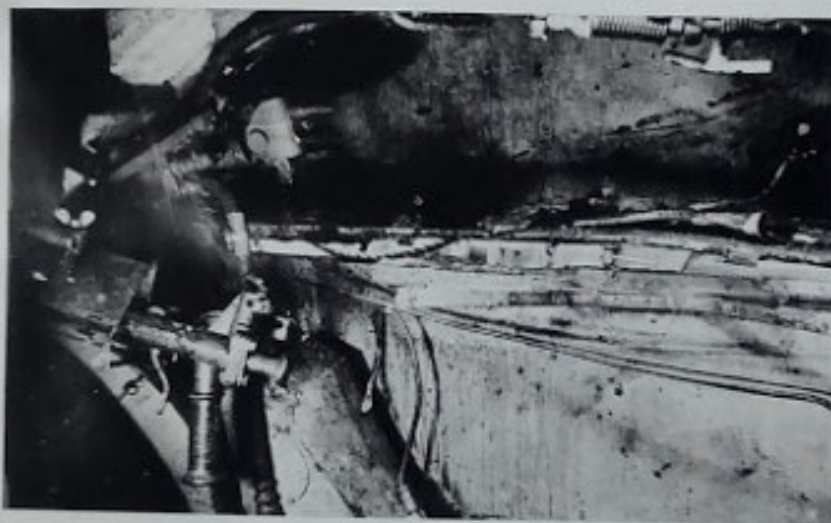
Print No.41.

View of forward  
portion of fractured  
joint between  
pannier floor and  
lower side armour  
after attack with  
25 pdr. H.E., Round  
65.

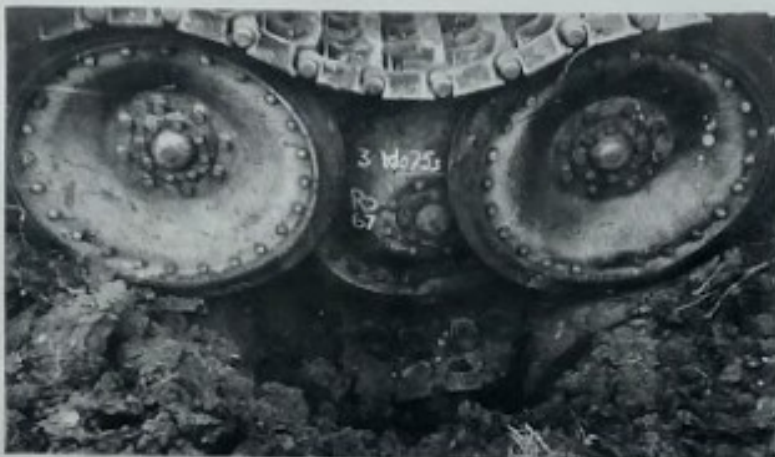
Print No. 43.

Rear end of offside track after detonation of three No. 75 grenades, Round 67. The track was fractured completely across at one point and half-way across at a point four links away.

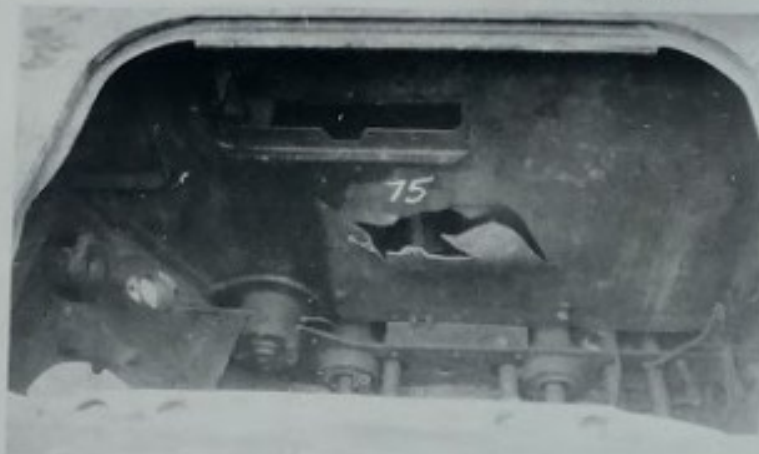
Print No. 45.

Damage to longitudinal bulkhead on nearside of engine compartment from 6 pdr. A.P.D.S. at 50°, Round 75, which perforated the lower side armour. The shot ripped open a fuel tank before striking this bulkhead. A very severe fuel fire broke out.

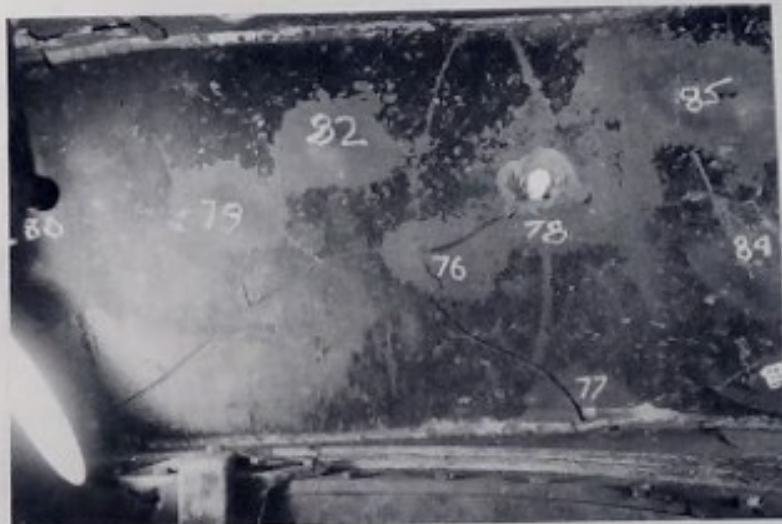
Print No.4.

Inside face of offside wall of turret.  
6 pdr. A.P. at 50°,  
Rounds 76 to 80.  
6 pdr. A.P.C. at 50°,  
Rounds 82 to 85.  
Note extensive cracking.

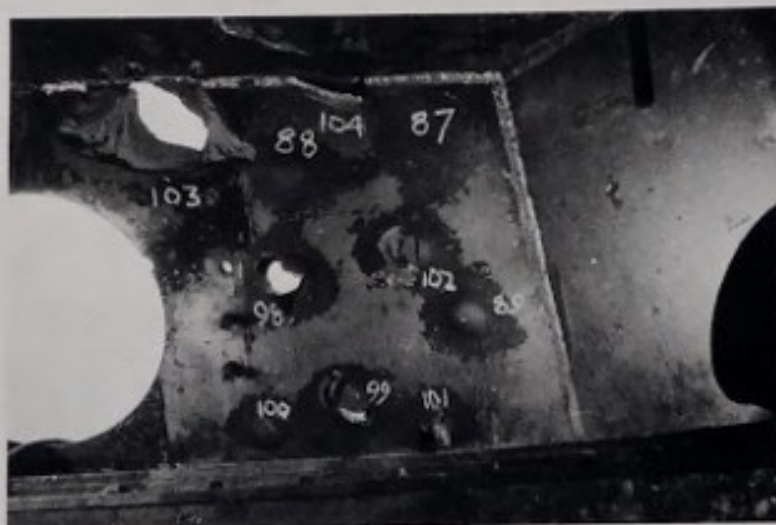
Print No.8.

Inner face of rear wall  
of turret after attack  
by:-  
6 pdr. A.P. at 50°,  
Rounds 87 to 89, and  
98 to 103.  
This plate had flakes  
dislodged from the inner  
face, as had all the  
other plates of the  
vehicle, but the  
extensive cracks which  
developed in the other  
plates did not occur in  
this plate.

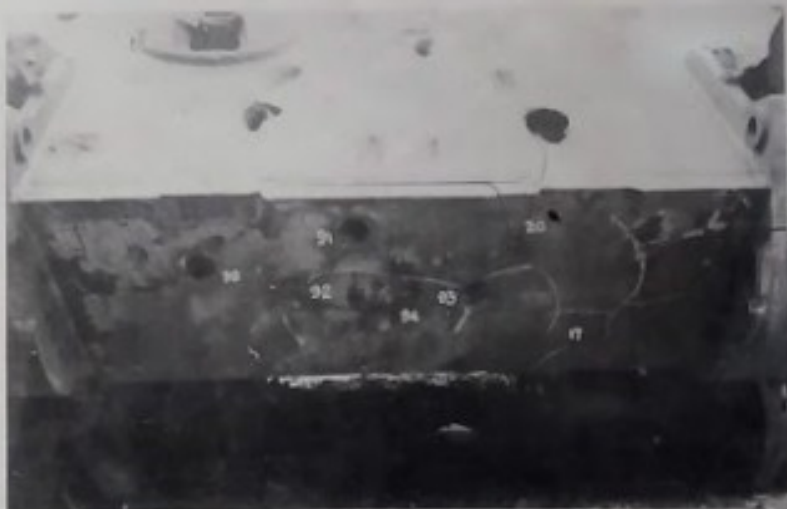
Print No.10.

Nose plate after  
attack by 17 pdr. A.P.  
at 53°, Rounds 90 to  
94.  
Note extensive  
cracking.

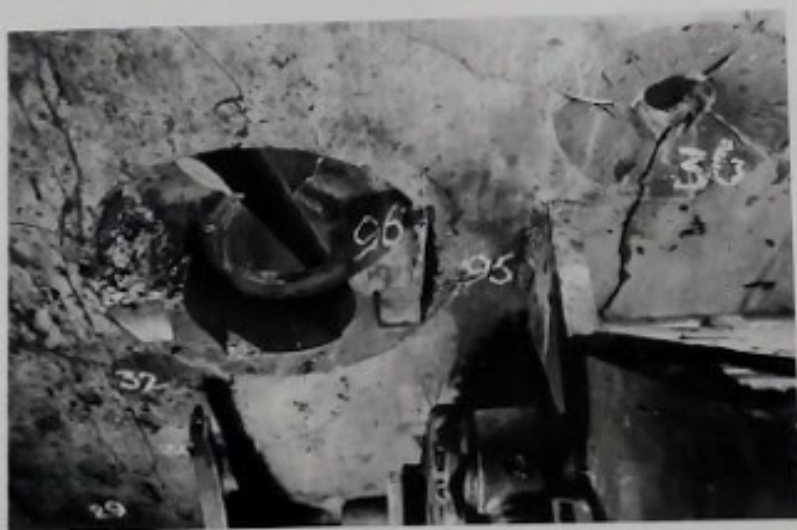
Print No.14.

Rear face of hull  
machine-gun ball  
mounting after attack  
by 17 pdr. A.P.,  
Rounds 95 and 96.  
Glacis plate after  
attack by 17 pdr.  
A.P.D.S. at 55°, Rounds  
29, 30 and 32, 17 pdr.  
A.P. at 55°, Round 36.  
Note extensive cracking  
of glacis plate.

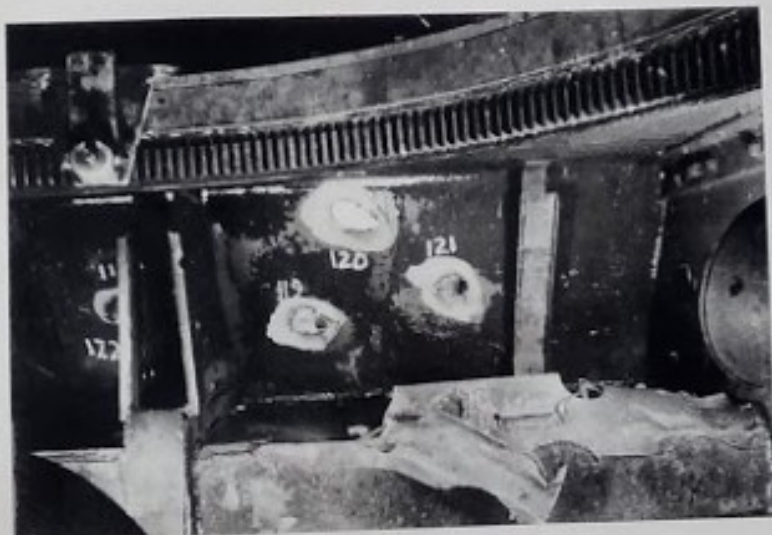
Print No. 22.

Showing back damage to  
offside pannier from  
6 pdr. A.P.C. at 50°,  
Rounds 119 to 122.  
Note excessive flaking  
and compare damage at  
Round 123 on Print 23  
where similar attack  
dislodged a plug from  
the same plate.

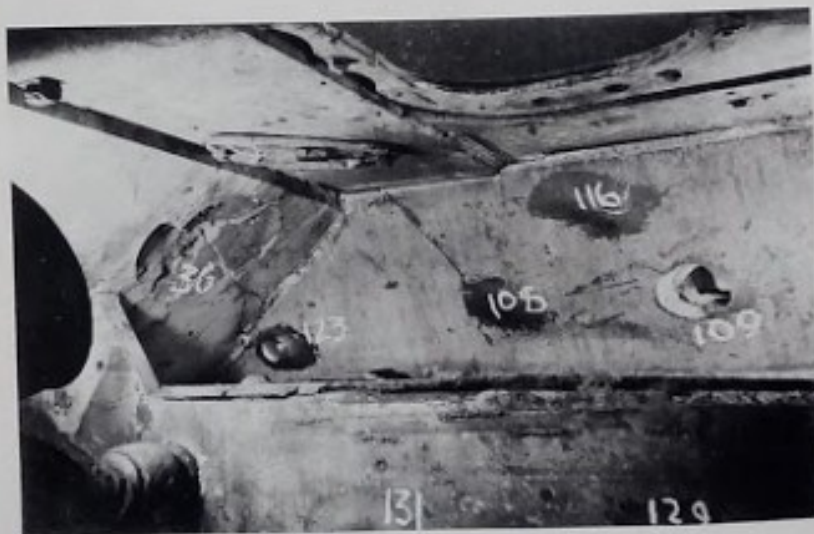
Print No. 23.

Back damage to front  
end of offside pannier  
from attack by:-  
6 pdr. A.P. at 50°,  
Rounds 108 and 109.  
6 pdr. A.P.C. at 50°,  
Rounds 116 and 123.  
Round 36 on the glacis  
plate was 17 pdr. A.P.  
at 55°.

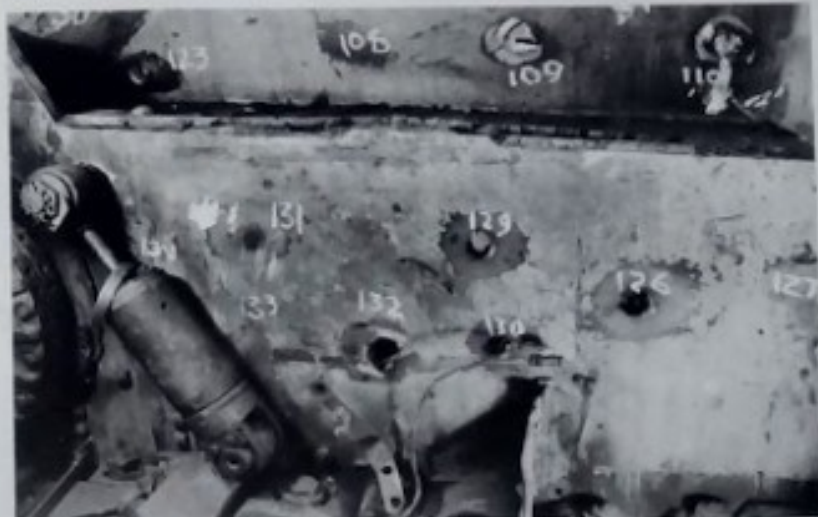
Print No.28.

Forward end of offside lower armour, showing variable back damage. Rounds 129, 126, and 130 forced out plugs, while Rounds 127 and 132 lifted or dislodged flakes.

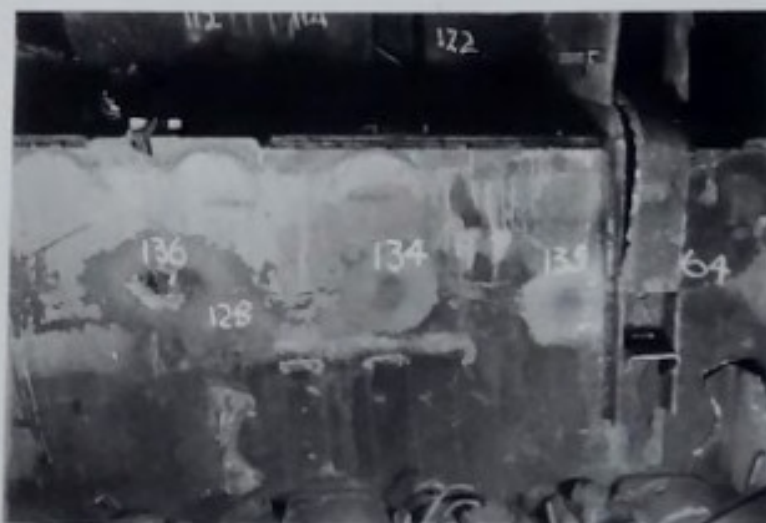
Print No.29.

Central portion of offside lower armour, showing back damage caused during 6 pdr. attack. The stiffening member was first damaged by Round 64 (75 mm. H.E.) and weld failures developed during 6 pdr. attack.

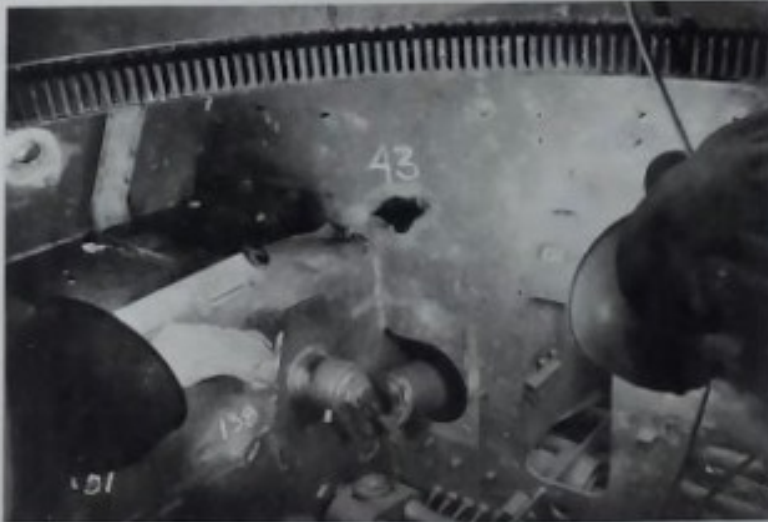
Print No.31.

Right rear corner of fighting compartment, showing hole in bulkhead caused by 6 pdr. A.P.C.B.C., Round 43, which defeated the turret side at 50° and penetrated the fuel tank behind the bulkhead and caused a severe fire.
