**ARMOUR BRANCH REPORT  
ON**

Comprehensive Firing Trials  
against  
German Panther Pz.Kw.V.

A.T. No. 232.

Project Nos. M. 6815A/4.  
Sheets 1-6.Subject.

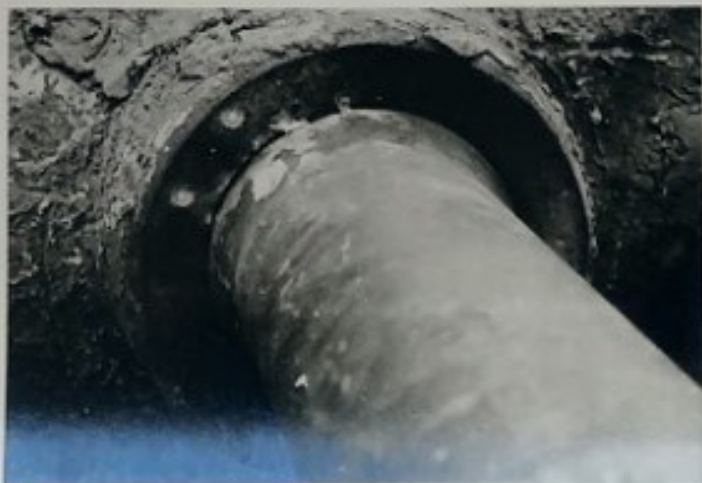
Print No.3.

Item No.2.  
Showing .303" Ball attack  
on 75 mm. gun aperture.  
Seven rounds effective.  
No splash entered.

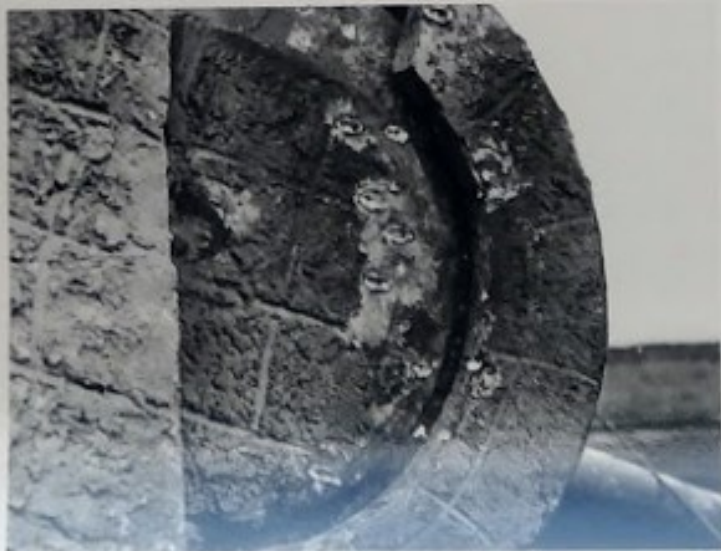
Print No.6.

Item No.11.  
Showing .303" A.P. attack at 20° to normal against turret gun mantlet side.

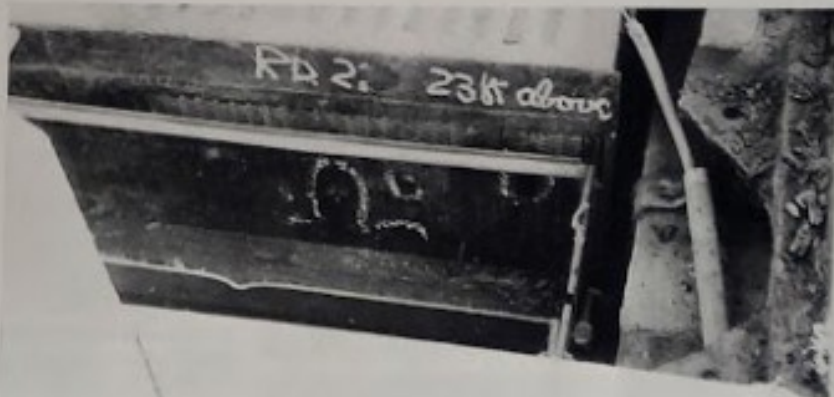
Print No. 9.

Round 2 detonating 11 ft. in front caused several perforations in the forward and rear radiators. The loss of water would have caused overheating and ultimate stoppage.

2.	23 ft.	11 ft.		1 perforation in rear left-hand radiator. Five perforations in forward left-hand side cooling radiator. Water leaking from four perforations. 1 perforation in rear right-hand radiator - forward right-hand side radiator not leaking. 3 perforations in rear right-hand radiator caused by fragments entering right-hand circular outlet grille. 2 perforations in forward left-hand radiator - largest 3" x 2 1/2". Water leaking freely.	Engine would have overheated and ultimately stopped.

Round 2. Burster  
board 23 ft. above  
and 11 ft. forward  
of louvre. Showing  
perforations in  
forward left-hand  
side radiator.

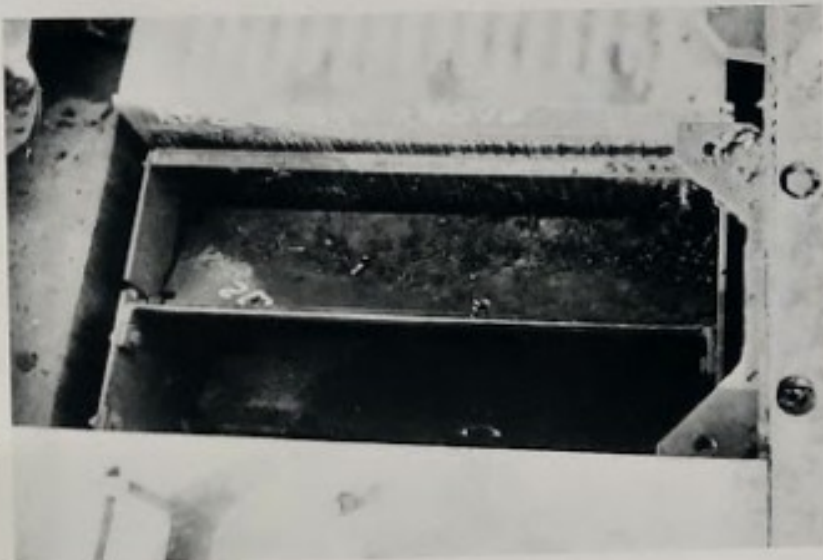
Print No.10.

Round 2. Burster board 23 ft. above and 11 ft. forward of louvre. Showing perforations in rear left-hand radiator and guide vanes.

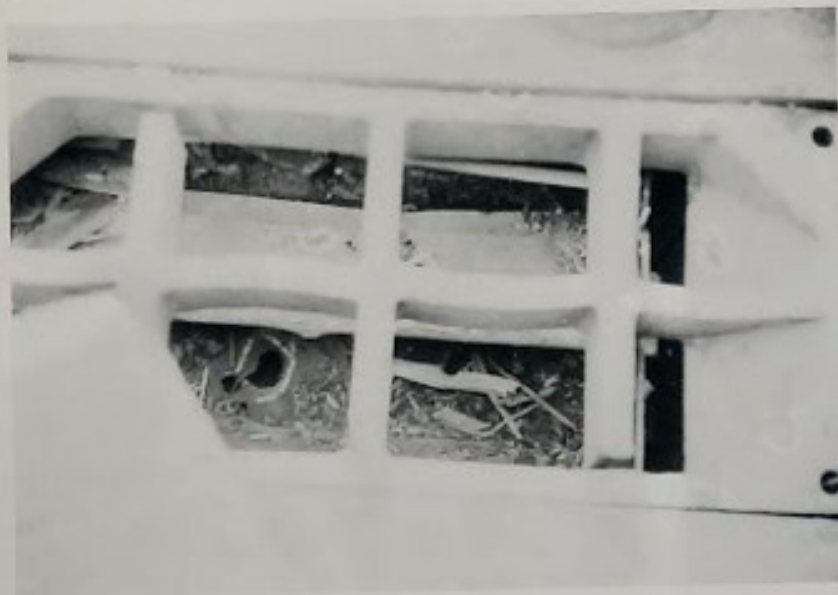
Print No.11.

Round 5 detonating 1 ft. in front produced further perforation of both of the forward radiators causing extensive damage, with considerable water loss.

Round 5. Burster board 5 ft. above and 1 ft. forward of louvre. Showing strikes on forward left-hand inlet louvre and perforations in guide vanes.

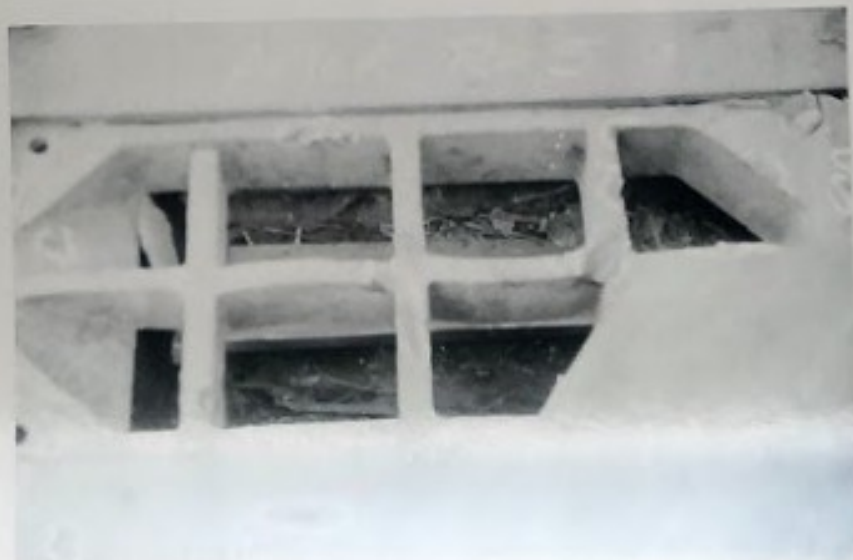
Print No.12.

Round 5. Burster board 5 ft. above and 1 ft. forward of louvre. Showing strikes on forward right-hand inlet louvre.

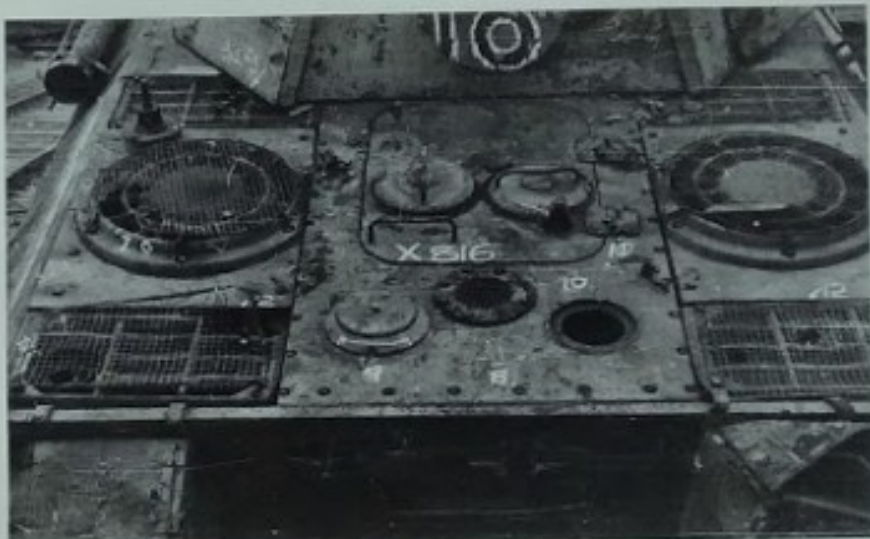
Print No. 13.

Five rounds directed against the roof showed the plate to be immune to 20 mm. attack at this angle and only slight local damage was caused.

Showing engine compartment roof after attack with 20 mm. Hispano A.P. from 27° above horizontal.

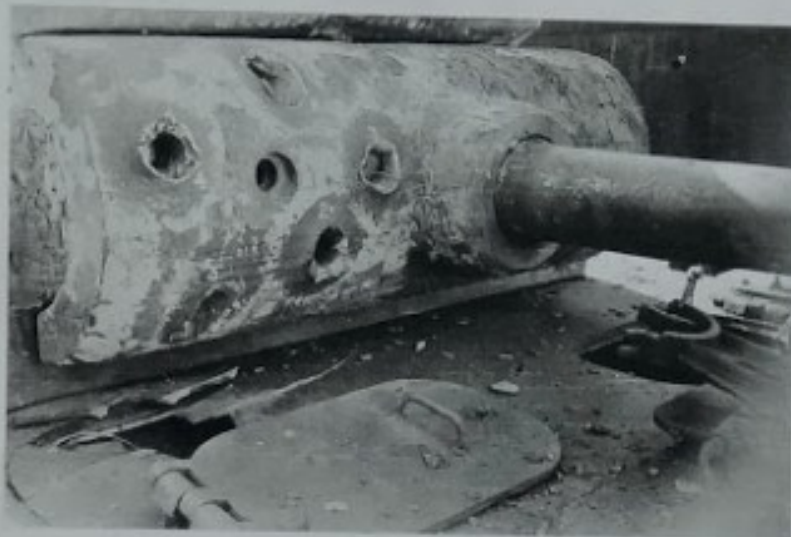
Print No. 1.

Five rounds of 6 pdr. A.P.C.B.C. were directed at the offside half of the mantlet, the thickness of which could not be measured. Strikes at velocities above 2300 f.s. holed the mantlet at its centre line and  $7\frac{1}{2}$ " above it, while a strike 4" below the centre line at a velocity 125 f.s. lower did not penetrate the mantlet, but was deflected downwards through the hull roof. The damage thus caused to the ammunition bin behind the hull gunner indicated that a cordite fire would probably have resulted had ammunition been stowed, and there is little doubt that the gunner would have been severely wounded by fragments of shot or roof plate.

Mantlet after attack by 6 pdr. A. P. C. B. C., Rounds 1 to 5. Round 5 scooped downwards and shattered the roof plate below. The hull gunner's hatch was dislodged due to the internal locking clamp being displaced.

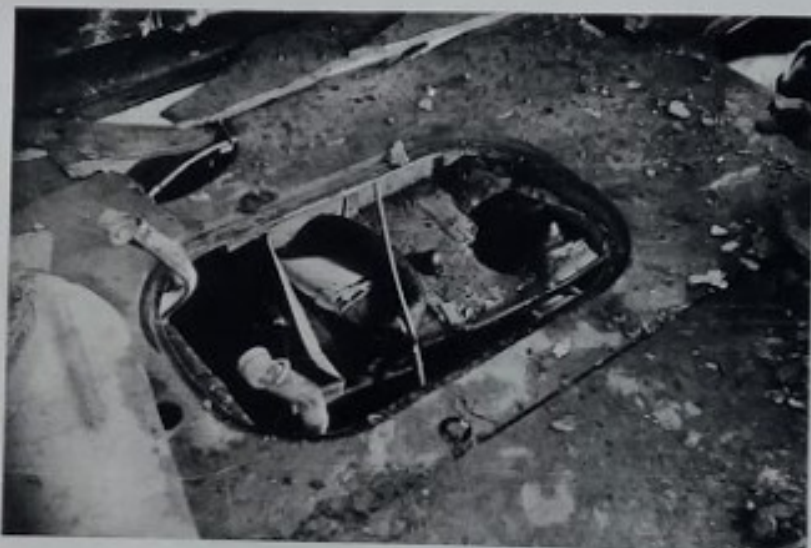
Print No. 7.

View looking into hull gunner's compartment after Round 5, 6 pdr. A.P.C.B.C., and Round 16, 75 mm. A.P.C.B.C. Shell, had scooped down off the mantlet and penetrated the roof plate.

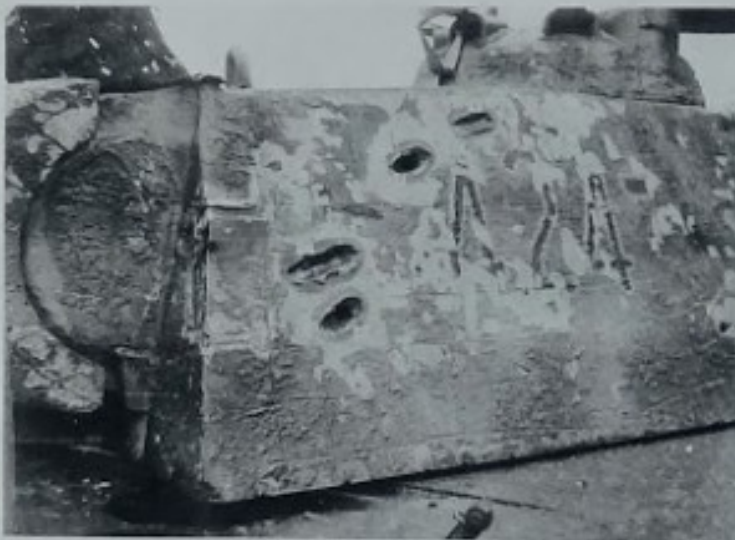
Print No. 10.

Nearside of turret  
after attack by 6 pdr.  
A.P.D.S. at 50°, Rounds  
21 and 22, and at 60°,  
Rounds 23 and 28.

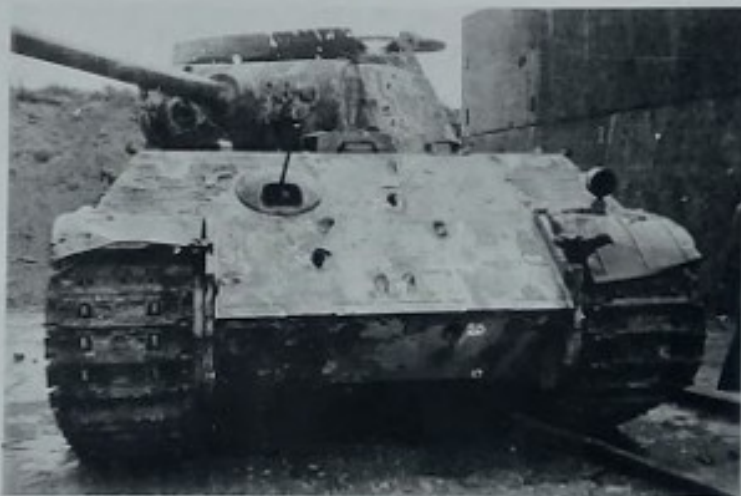
Print No. 11.

Glacis plate after  
attack by 17 pdr.  
A.P.D.S. at 55°, Rounds  
29 to 33.  
Rounds 13, 18, 19 and  
26 on the glacis plate,  
and Rounds 17 and 20 on  
the nose plate, were  
6 pdr. A.P.D.S.

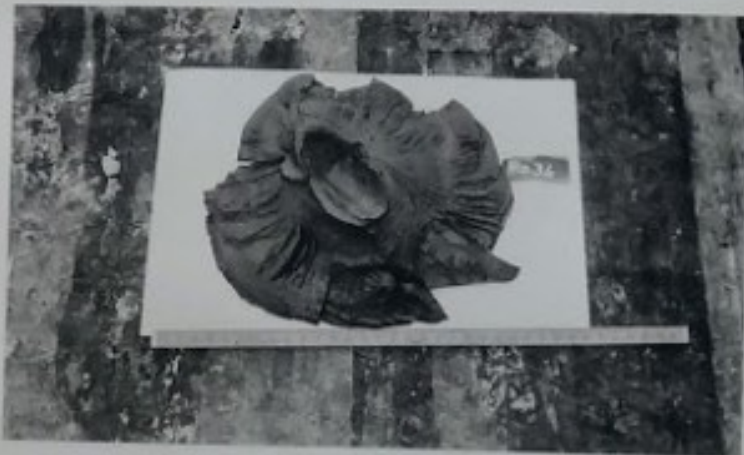
Print No.13.

Showing flake dislodged from rear face of glacis plate by 17 pdr. A.P.C.B.C. at 55°, Round 34. The flake was recovered at the end of the trial after the final drive and its support had been removed.

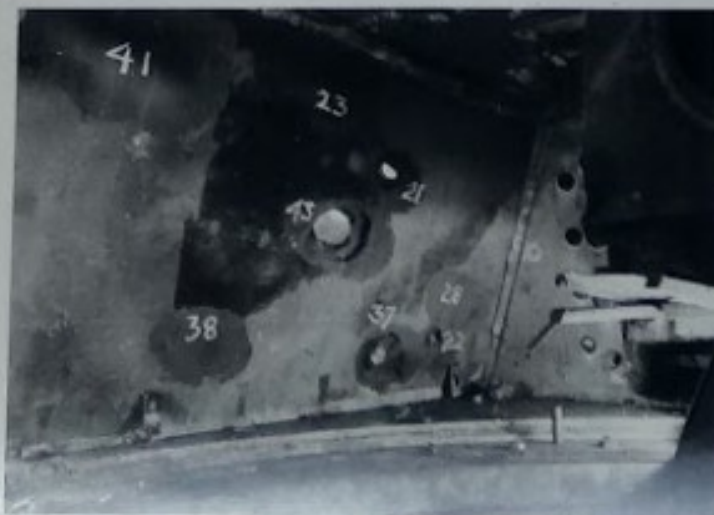
Print No.21.

Inner face of nearside wall of turret after attack by 6 pdr. A.P.D.S. at 50°, Rounds 21 and 22, at 60°, Rounds 23 and 28, and from 6 pdr. A.P.C.B.C. at 50°, Rounds 37, 38, 41 and 43. Round 10 was 6 pdr. A.P.D.S. on the front face of the turret. Note typical flaking where plate was overmatched.

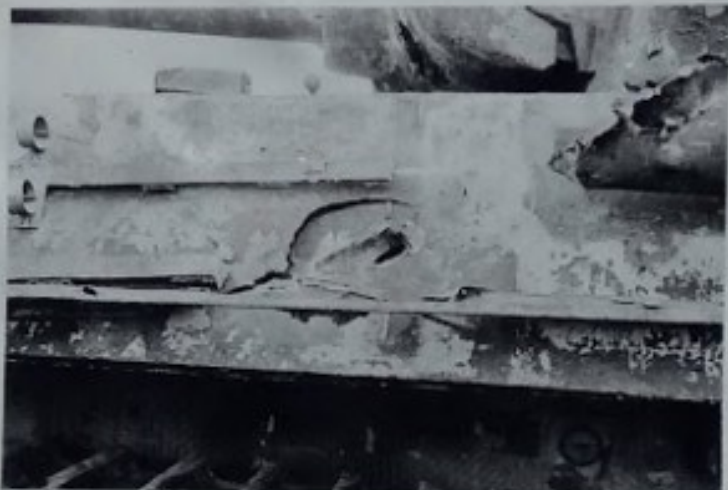
Print No. 22.

Nearside pannier after  
attack by 6 pdr.  
A. P. C. B. C. at 50°,  
Rounds 44 and 45.  
Round 45 struck 6" from  
Round 44 and is  
therefore not a fair  
strike.

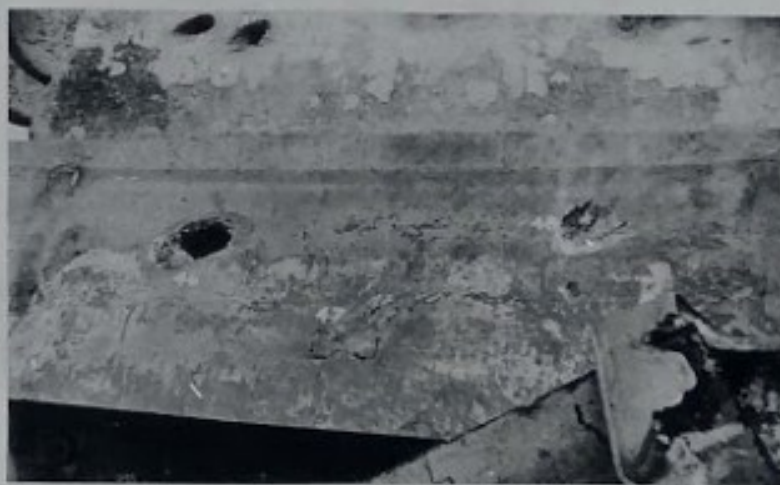
Print No. 26.

Nearside pannier after  
attack by 6 pdr.  
A. P. C. B. C. at 50°,  
Rounds 46 to 48.  
Round 46 holed the  
armour at S. V. 2373 f.s.

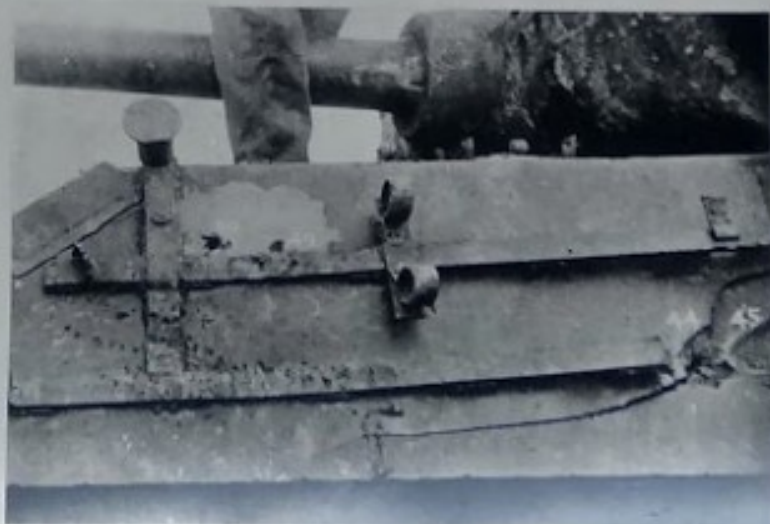
Print No. 27.

Forward end of nearside  
pannier after attack by  
3-lb. P. I. A. T. at 30°.  
Round 49 did not hole  
the armour.  
Round 50 made a hole 1/2"  
diameter and the offside  
pannier was marked by  
fragments.

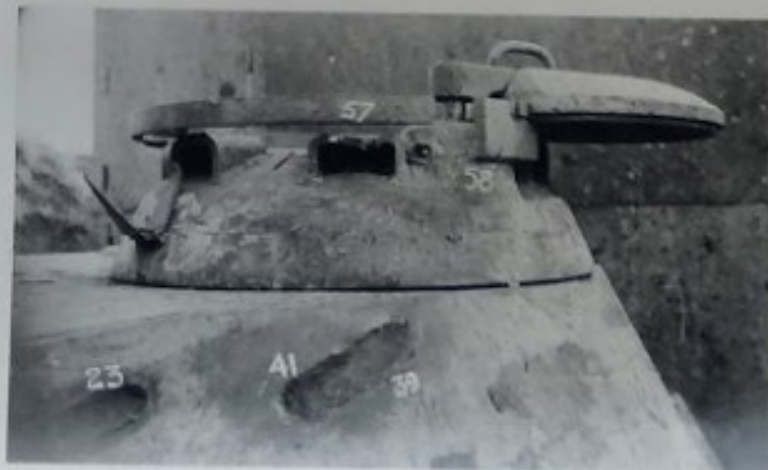
Print No. 30.

Cupola after removing  
lodged tail of 3-lb.  
P.I.A.T., Round 58.  
The boss for the hinge  
pillar was penetrated  
and had the hatch been  
closed, the jet would  
have struck the hinge  
arm without causing  
casualties.

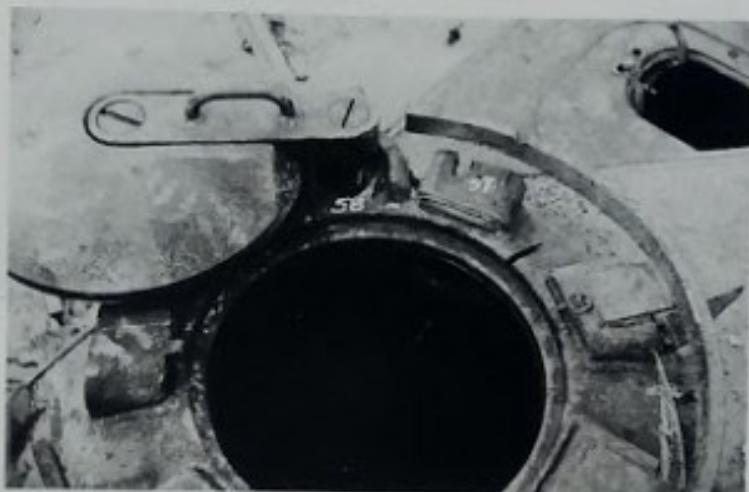
Print No.31.

Cupola after attack by  
3-lb. P.I.A.T., Rounds  
57 and 58.  
Note bracket dislodged  
from machine-gun guide  
rail by Round 57.  
See also Prints 29 and  
30.

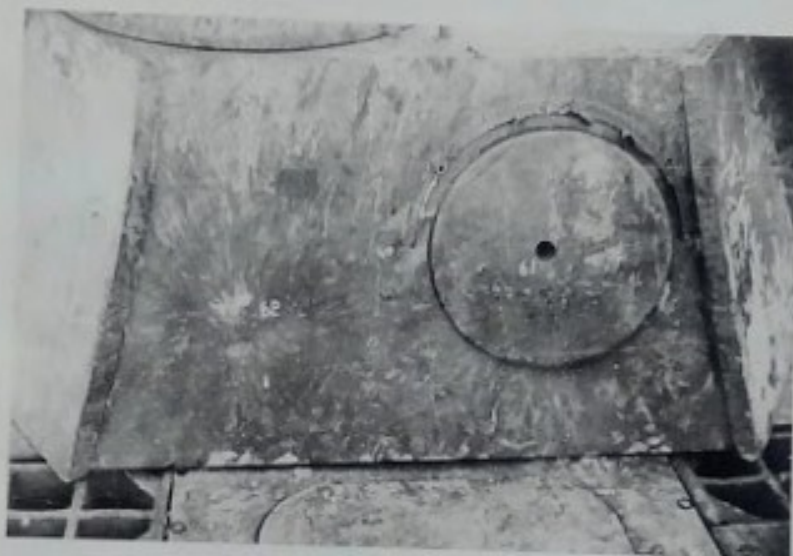
Print No. 34.

Rear wall of turret after detonation of 75 mm. H.E., Round 61, and 25 pdr. H.E., Round 62. Fragments from both rounds cut into the radiator matrix at nearside and offside. The circular escape door was jammed after Round 62.

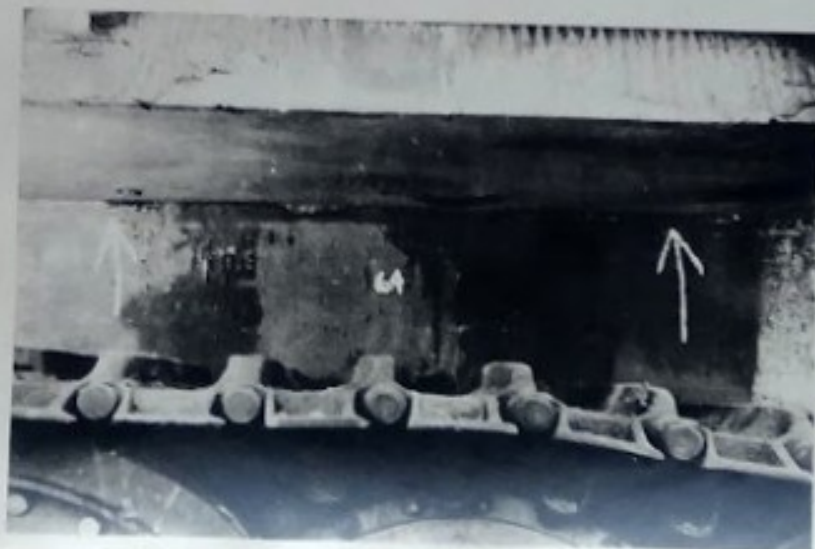
Print No. 36.

Offside lower side armour after detonation of 75 mm. H.E., Round 64, 6" below pannier floor. Weld between pannier floor and side armour fractured for 38".

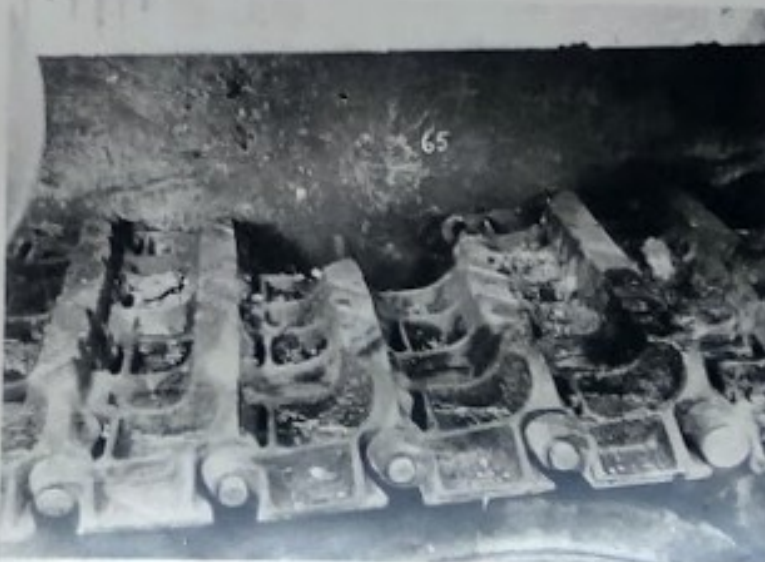
Print No. 39.

Damage to track from 25 pdr. H.E., Round 65, which detonated immediately above track. Track was not severed but displaced portion, which was forced downwards, would probably have caused a stoppage by fouling the driving sprocket.

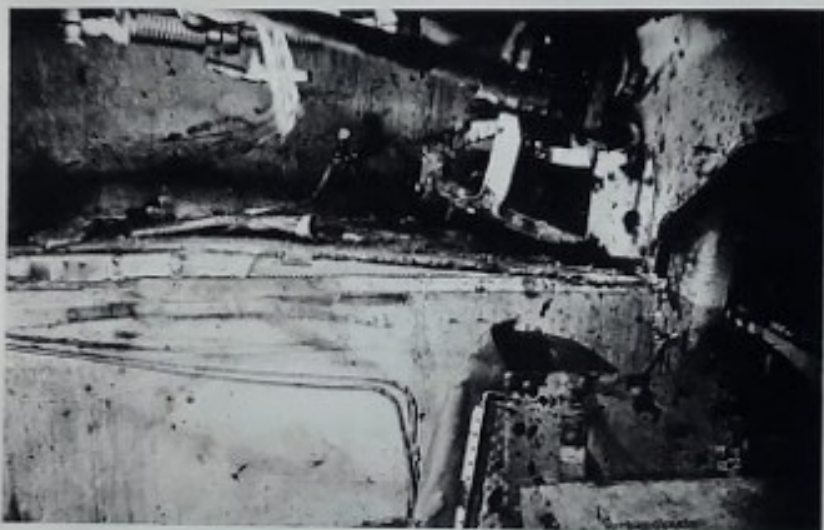
Print No.40.

Internal view of  
offside pannier  
after 25 pdr. H.E.,  
Round 65, had  
detonated against  
the lower armour.

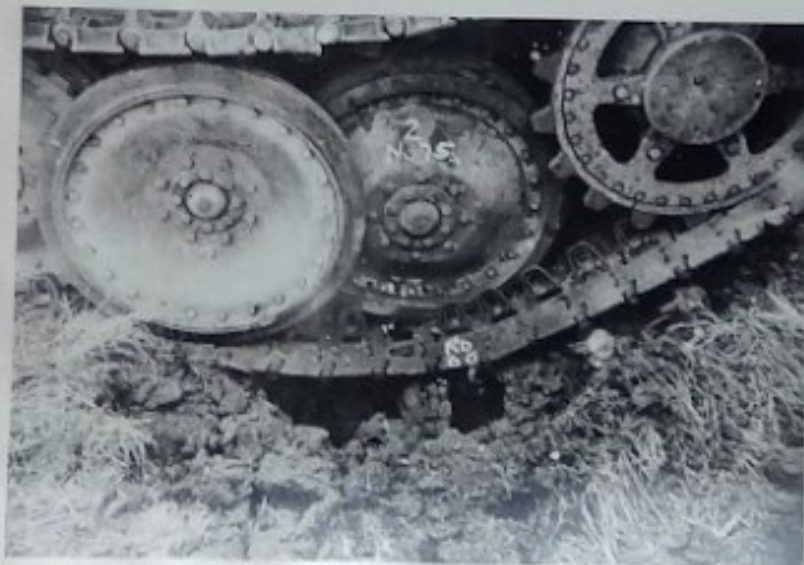
Print No.42.

Forward end of  
offside track after  
detonation of two  
No.75 Grenades  
placed one above the  
other, and 8" from  
outer edge of track.  
The track was not  
severed.

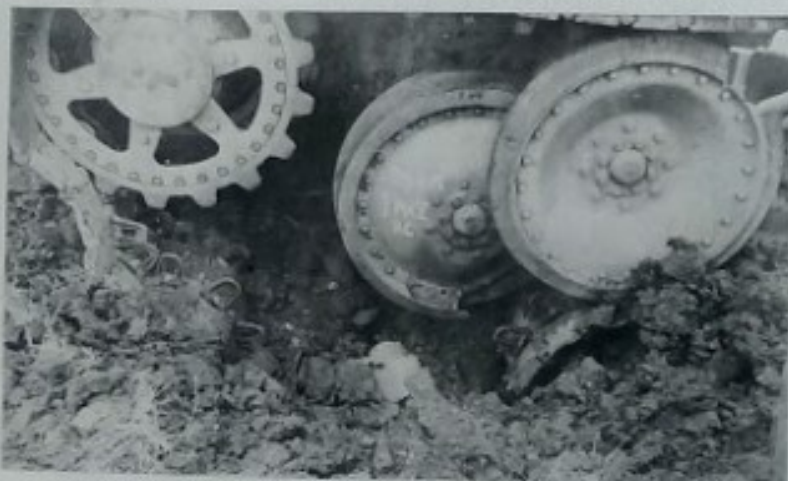
Print No. 44.

Front end of nearside track after detonation of one Mk. V H.C. A. T. Mine, Round 68. Track severed. Note damage to rim of first road wheel.

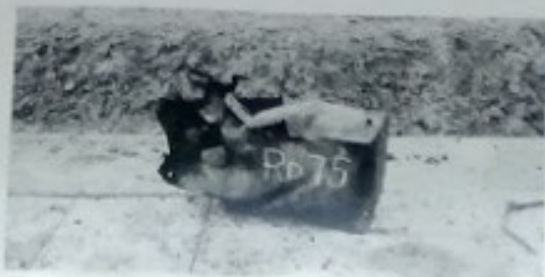
Print No. 46.

Fuel tank which was penetrated by Round 75, 6 pdr. A.P.D.S. The core evidently broke up on passing through the armour and the fragments caused this damage to the tank. Then to the bulkhead seen above.

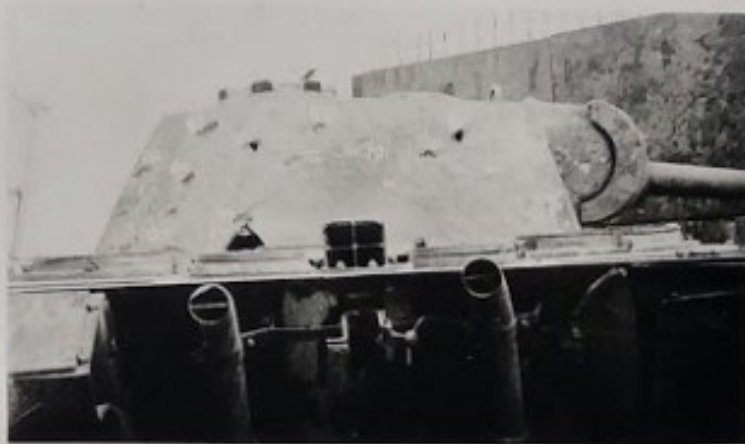
Print No. 1.

Offside wall of turret  
after attack by:-  
6 pdr. A.P. at 50°,  
Rounds 76 to 81, and 86.  
6 pdr. A.P.C. at 50°,  
Rounds 82 to 85.  
Round 63 was 25 pdr. H.E. fired during Part II of the trial.

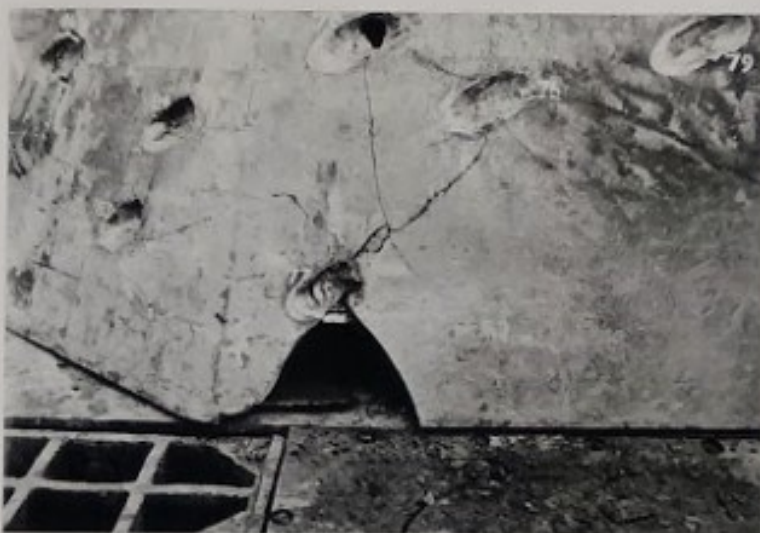
Print No. 2.

Offside wall of turret  
at bend after attack  
by:-  
6 pdr. A.P. at 50°,  
Rounds 76 to 79, and 86.  
6 pdr. A.P.C. at 50°,  
Rounds 83 and 84.  
The triangular portion  
of the armour below  
Round 77 was dislodged  
by Round 84.  
Round 77 struck on the  
level of the turret  
floor plate.

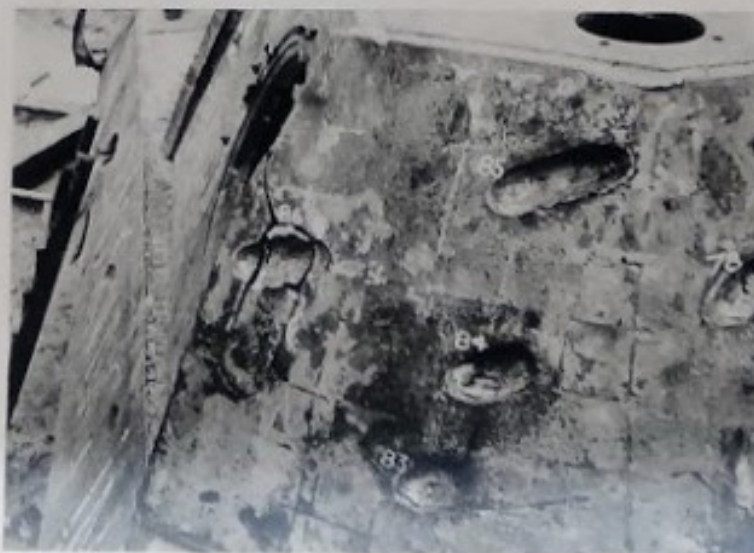
Print No. 3.

Rear offside wall of  
turret after attack by:-  
6 pdr. A.P. at 50°,  
Round 86.  
6 pdr. A.P.C. at 50°,  
Rounds 83 to 85.  
Round 86 struck on the  
tenon of the interlocking  
joint formed by the rear  
plate.

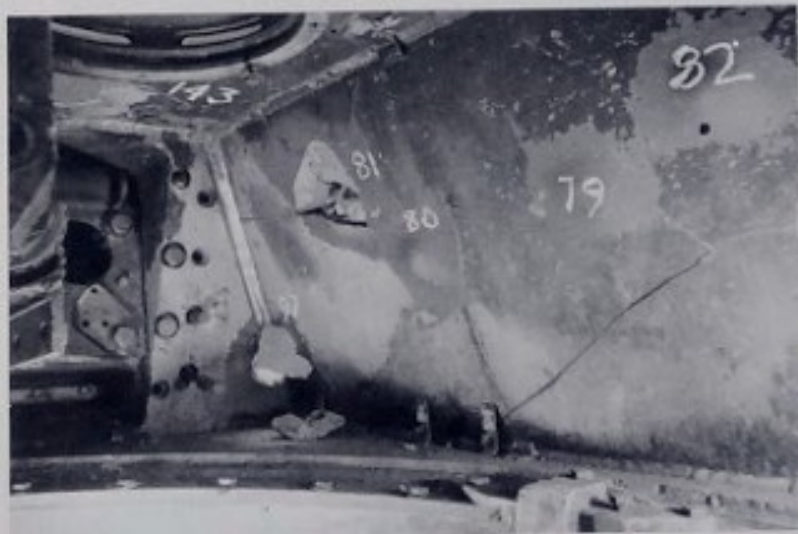
Print No.5.

Showing inner face of offside wall of turret after attack by:-  
6 pdr. A.P. at 50°,  
Rounds 79 to 81.  
6 pdr. A.P.C. at 50°,  
Round 82.  
17 pdr. A.P. at normal  
on the front face of  
the turret, Round 97.

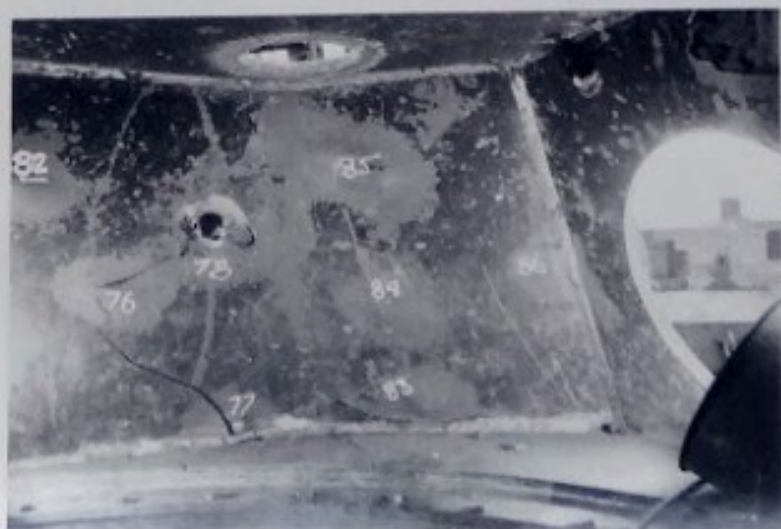
Print No.6.

Inner face of offside turret wall after attack by:-  
6 pdr. A.P. at 50°,  
Rounds 76 to 78, and 86.  
6 pdr. A.P.C. at 50°,  
Rounds 82 to 85.

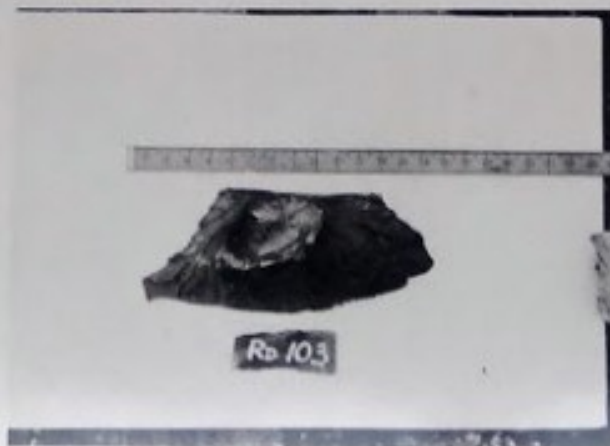
Print No.9.

Flake off rear wall of turret  
caused by 6 pdr. A.P. at 50°,  
Round 103.

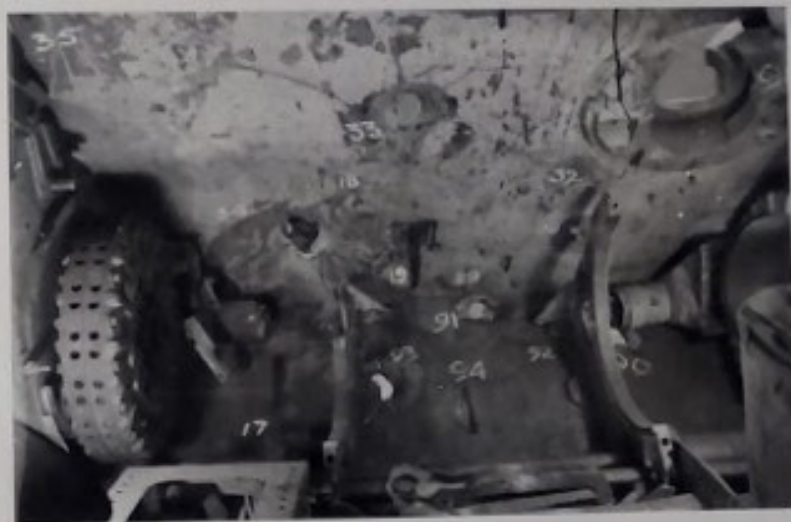
Print No.11.

Nose plate after  
attack by:-  
6 pdr. A.P.D.S. at 53°,  
Round 17.  
17 pdr. A.P. at 53°,  
Rounds 90 to 94.  
Glacis plate after  
attack by:-  
6 pdr. A.P.D.S. at 55°,  
Rounds 18 and 19.  
17 pdr. A.P.D.S. at 55°,  
Rounds 29, 30, 32 and  
33.  
17 pdr. A.P.C.B.C. at  
55°, Rounds 34 and 35.  
The left-hand trans-  
mission bracket was  
flame-cut to permit  
removal of flake  
dislodged by Round 34.

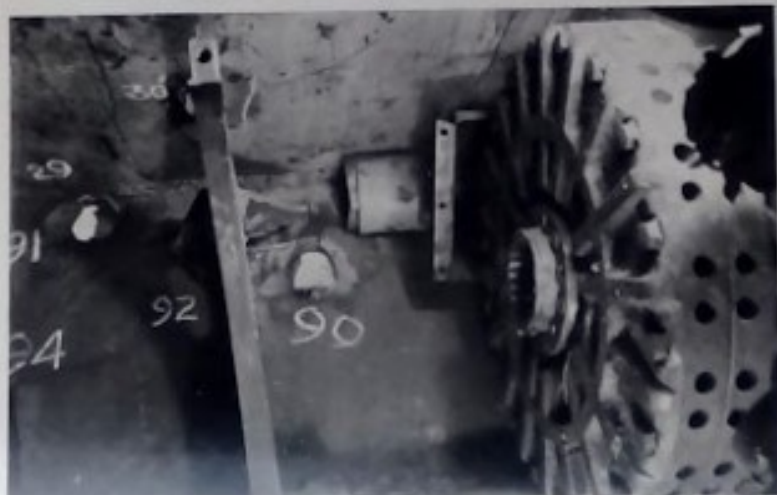
Print No.12.

Nose plate after attack  
by:-  
17 pdr. A.P. at 53°,  
Rounds 90 to 92, and 94.  
Glacis plate after  
attack by:-  
17 pdr. A.P.D.S. at 55°,  
Rounds 29 and 30.

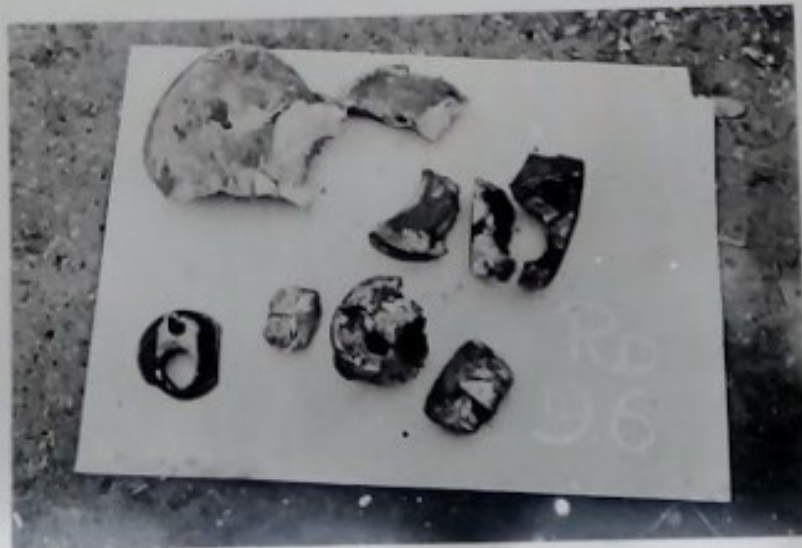
Print No.15.

Fragments of ball  
mounting recovered  
from inside hull,  
mounting projected  
into hull by Round 96,  
17 pdr. A.P.  
The large portion, top  
left, was found  
outside and is part of  
the domed upper  
housing.

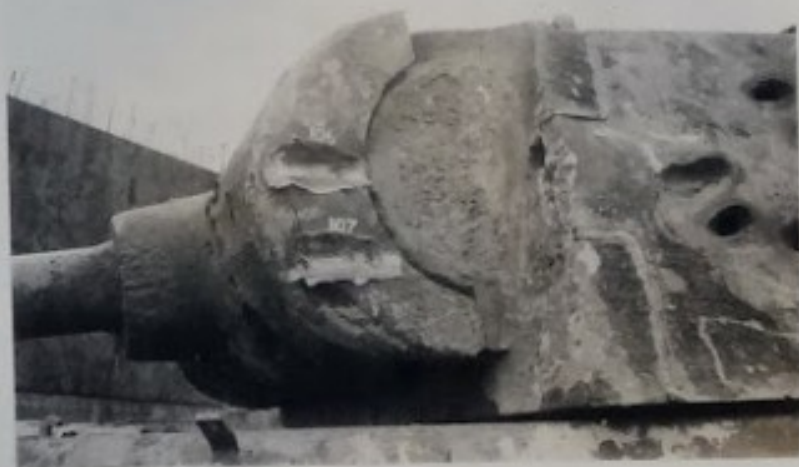
Print No.17.

Showing nearside edge  
of turret mantlet  
after attack by:-  
6 pdr. A.P. at 60°,  
Rounds 106 and 107.  
The mantlet was not  
jammed by this attack,  
but rubbing between  
the mantlet and turret  
front occurred in  
places.

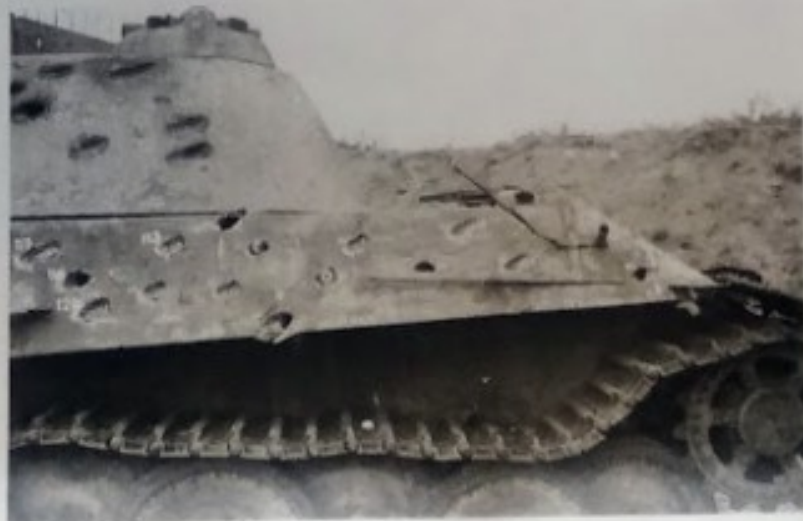
Print No.18.

Offside pannier after  
attack by:-  
6 pdr. A.P. at 50°,  
Rounds 108 to 113.  
6 pdr. A.P.C. at 50°,  
Rounds 114 to 118, and  
122 to 125.  
See also Print No.19.

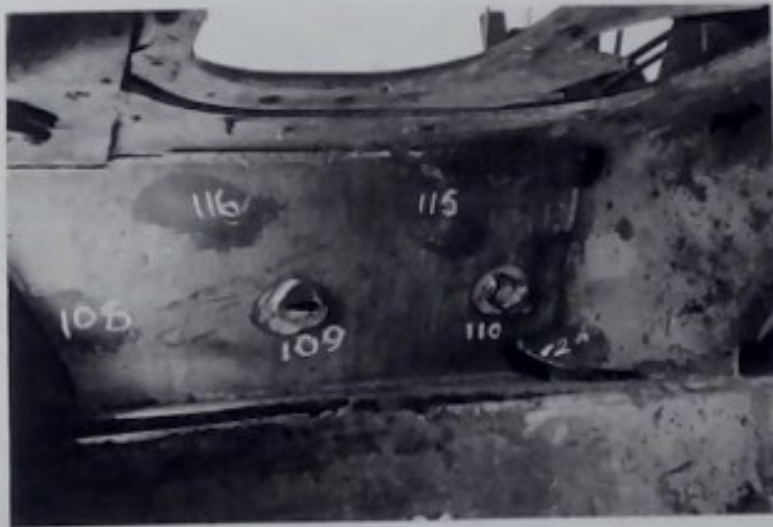
Print No. 20.

Interior of offside  
pannier after attack by:-  
6 pdr. A.P. at 50°,  
Rounds 108 to 110.  
6 pdr. A.P.C. at 50°,  
Rounds 115 and 116.  
The bottom corner of the  
bulkhead was forced  
forward by Round 124.

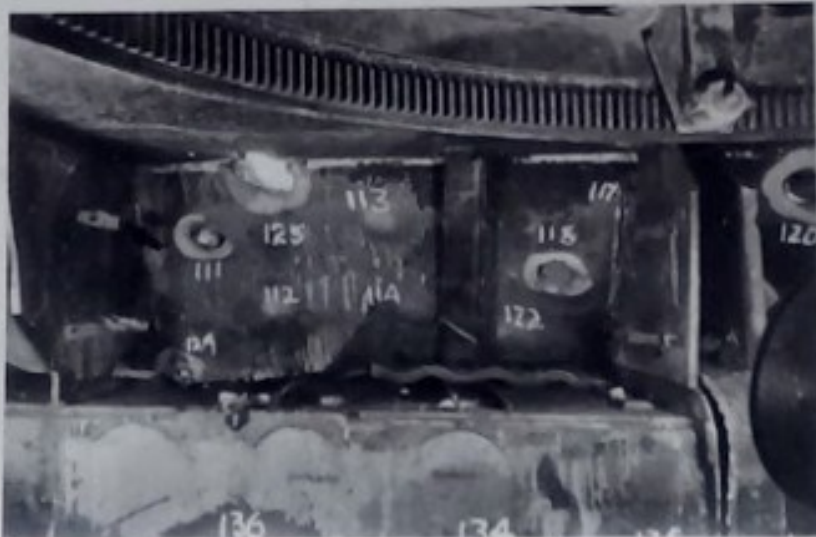
Print No. 21.

Offside pannier  
showing back damage  
from:-  
6 pdr. A.P. at 50°,  
Rounds 111 to 113.  
6 pdr. A.P.C. at 50°,  
Rounds 114, 117, 118,  
120, 122, 124 and 125.

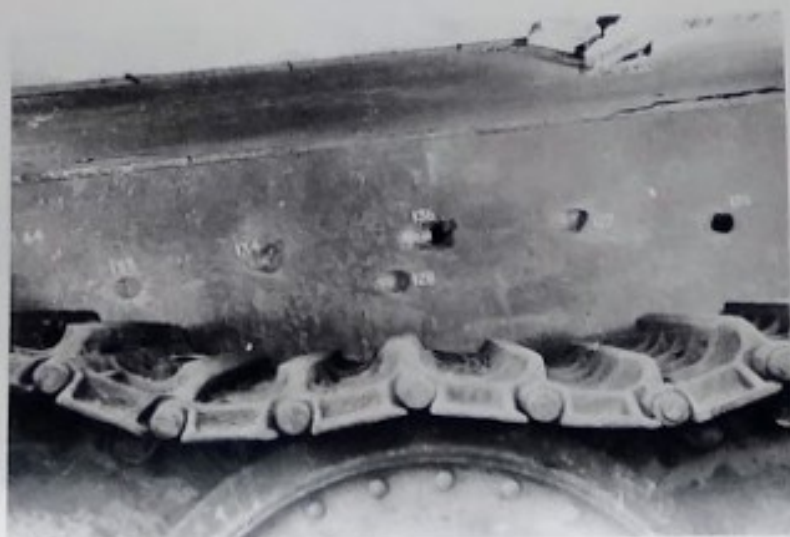
Print No. 24.

Offside lower armour  
after attack by:-  
6 pdr. A.P. at 50°,  
Rounds 126 to 128.  
6 pdr. A.P.C. at 50°,  
Rounds 134 to 136.  
(Round 64 was 75 mm. H.E.  
fired during Part II of  
this trial.)

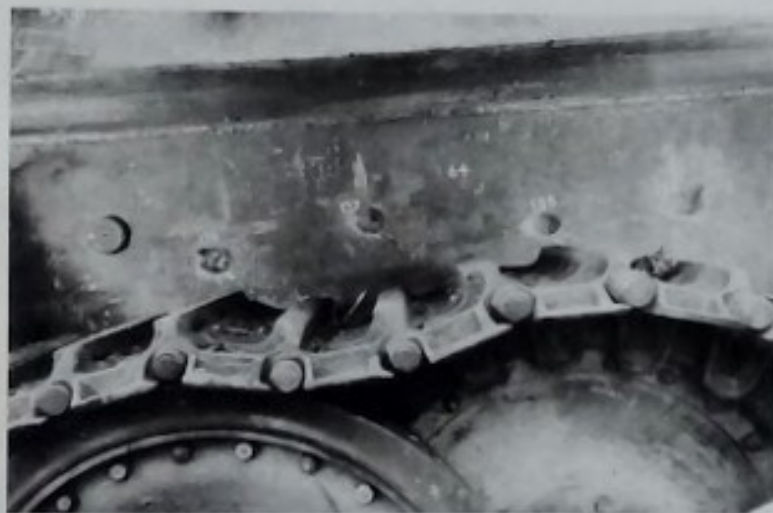
Print No. 26.

Offside lower armour.  
Rounds 134 to 138 were  
6 pdr. A.P.C. at 50°.  
Round 64 was 75 mm. H.E.  
fired during Part II of  
the trial.

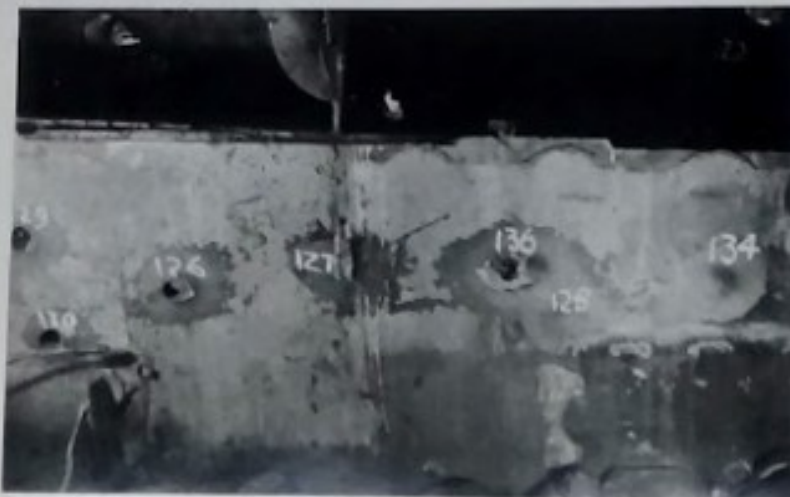
Print No. 27.

Back damage of lower  
armour at offside after  
6 pdr. A.P. and A.P.C.  
attacks.  
Note tendency to form  
plugs at Rounds 126,  
129, 130; and flake  
lifted at Round 127.  
See also Print No. 28.

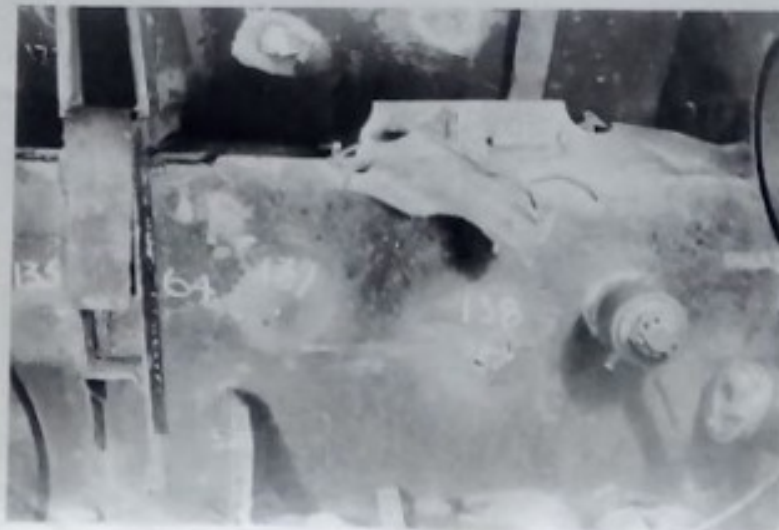
Print No.30.

Another view of damaged stiffening device below bulkheads in pannier. Note that piston rod of the rear suspension system is fractured, possibly as a result of the detonation of three A.T. grenades (Round 67) beneath the track.

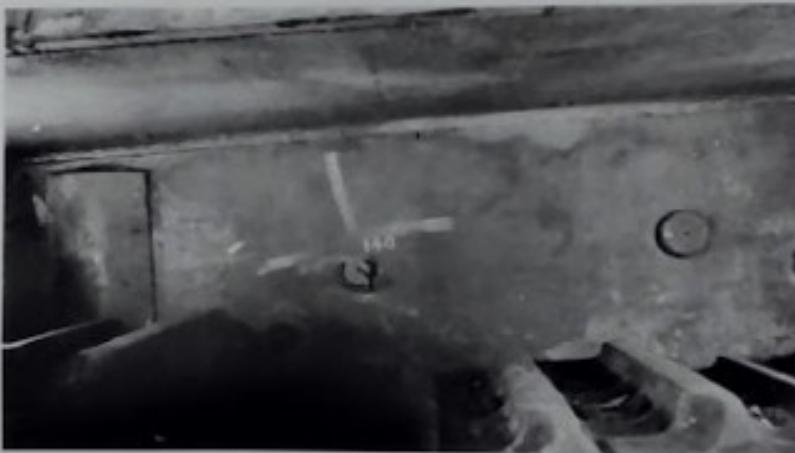
Print No.32.

6 pdr. A.P.C., Round 140, defeated the lower armour at 50° at a velocity equivalent to a range of 2300 yds.

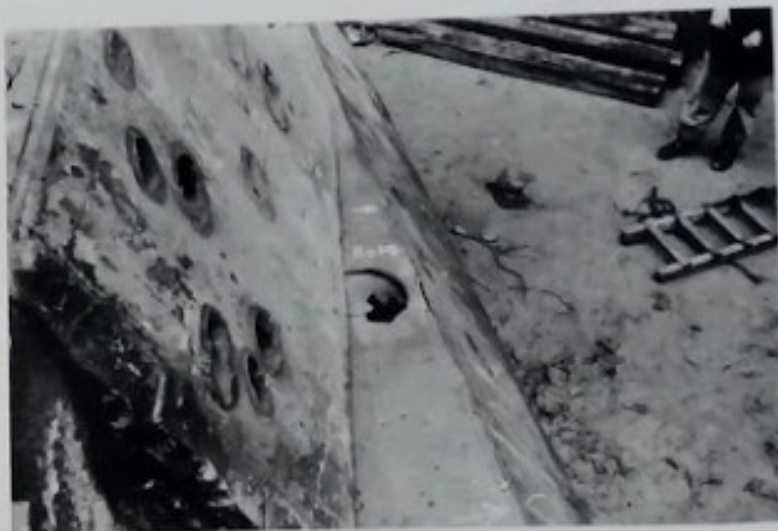
Print No.34.

Hole blown in hull roof  
by No.75 grenade  
detonated in contact.  
Ammunition for the 75 mm.  
gun is stowed below this  
point.  
Roof plate was 17 mm.  
thick.

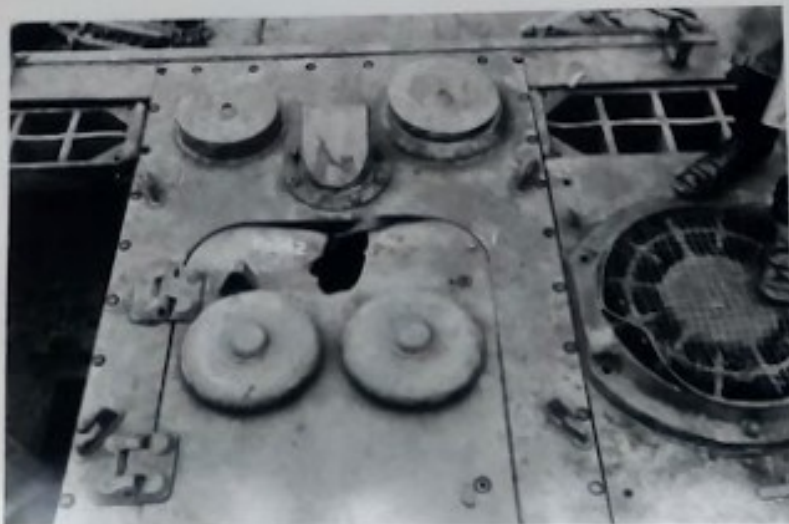
Print No.36.

Result of detonation of  
No.75 grenade on hatch  
over engine compartment.  
Hatch was 17 mm. thick.

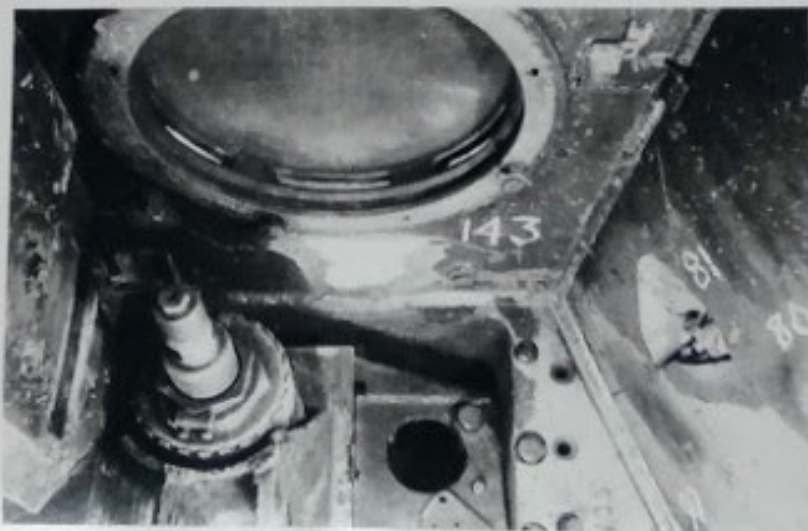
Print No.39.

<u>TARGET</u>	<u>ATTACK</u>	<u>OBSERVATIONS</u>
Front of turret roof plate.	Round 143 No.75 Grenade. Filled 704 B. Detonated. electrically.	Detonation. Hole 6"x5". Area 16"x7" forced downwards max. of $\frac{1}{2}$ ". Lifting eye at offside fractured.. Weld attaching inner end of eye broken. Cracks in junction adjacent roof plate (weld to turret front) 8"x1 $\frac{1}{4}$ " long. Weld to protector around ventilator cover fractured 5" in junction to protector. Flake-off 9"x6 $\frac{1}{2}$ ". Back edge of turret front forced down $\frac{3}{8}$ ". Weld between turret front and roof cracked 6". Fragments of roof caused damage to offside buffer casing and would have seriously damaged machine gun mounting if in position.

Interior of turret  
roof after detonation  
of Round 143.  
The hole measured  
6" x 5" and the area  
from which the flake was  
removed 9" x 6 1/2".

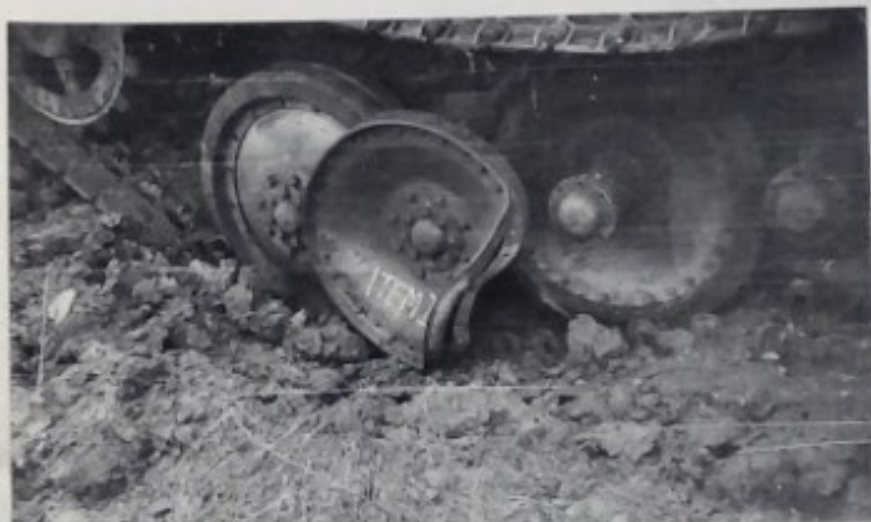
Print No. 1.

TARGET	ATTACK	OBSERVATIONS
<p>Tank No. 3031 Item No. 1. Under centre of L.H. track in line with No. 2 bogie. (Spaced flange wheels).</p>	<p>One 4-lb. Non-detectable mine placed with top of mine 2" below lower edge of track. Mine filled T.N.T. (4 lb) with C.E. exploder pellet and No. 33 electric detonator inserted into a side orifice.</p>	<p>Mine failed to detonate. On inspection the casing was found to be broken open and filling exposed. One lb. of gun cotton was placed alongside to detonate the mine. This caused mine to explode. Crater area 4' dia x 18" deep. The outer bogie disc No. 2 was severely buckled and tyre thrown off. Two track guide lugs immediately behind the outer disc were fractured and the track bulged inward approx. 2" over an area 6" x 4", centrally across the width of the track. One link broken. Owing to the splitting of the mine casing the filling was unconfined and therefore unlikely to develop its full power. It is considered that the vehicle would still be capable of running.</p>

Item No. 1.  
Result from 1-4 lb.  
non-detectable  
mine plus 1 lb. of  
gun cotton under  
centre of left-hand  
track and beneath  
No. 2 bogie.

Note:-  
Track dished  
locally.

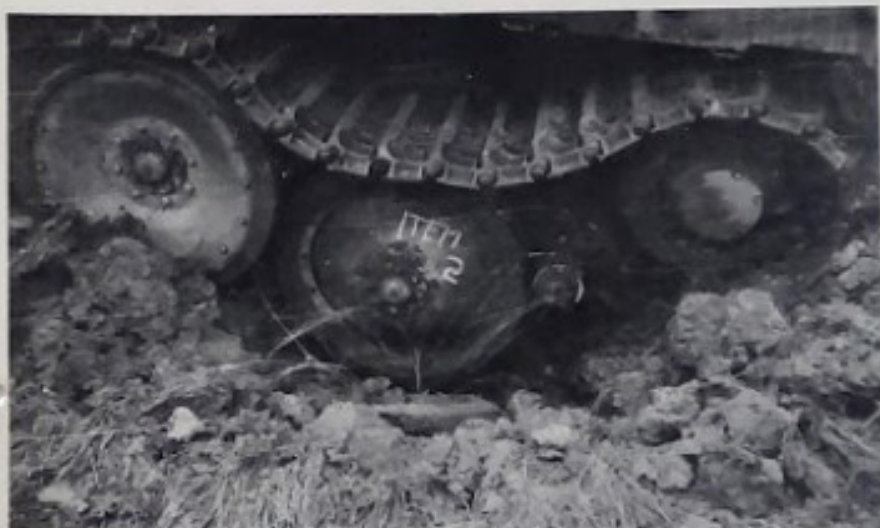
Print No. 2.

Item No. 2.  
Result from 1-Mk. V  
reduced depth A. T.  
mine under centre  
of left-hand track  
and in line with  
No. 8 bogie.

Note:-  
Track completely  
broken.
