**ARMOUR BRANCH REPORT  
ON**

Comprehensive Firing Trials  
against  
German Panther Pz.Kw.V.

A.T. No. 232.

Project Nos. M. 6815A/4.  
Sheets 1-6.Subject.

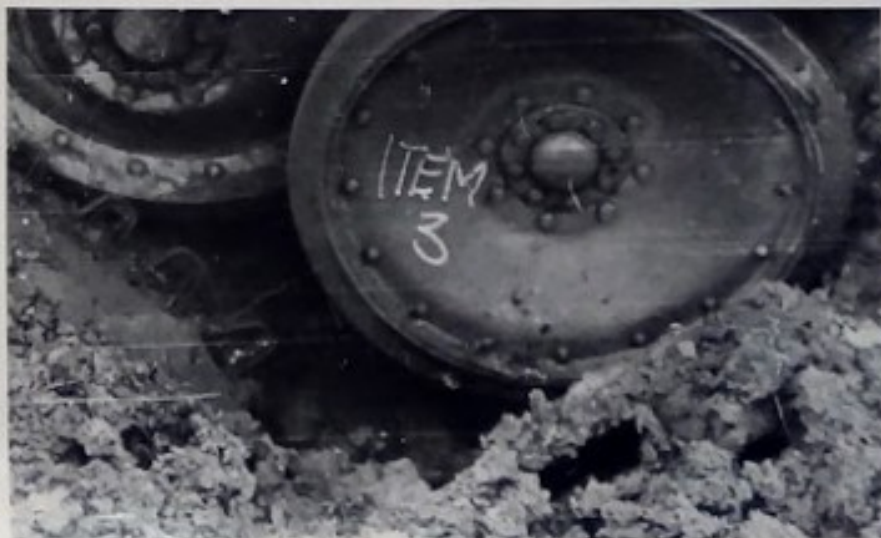
Print No. 3.

Item No. 3.  
Result from 1-4 lb.  
non-detectable mine  
under centre of  
left-hand track and  
in line with No. 6  
bogie.  
Track completely  
broken.

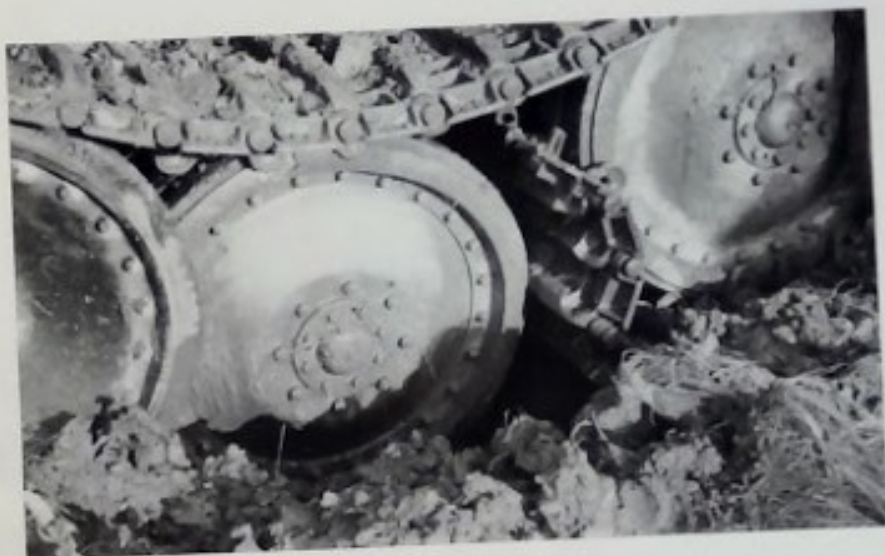
Print No. 4.

Item No. 4.  
Result from 1-Mk. V  
standard A. T. mine  
under inner edge  
of left-hand track  
and in line with  
No. 3 bogie.

Note:-  
Track completely  
broken. Hull  
intact.

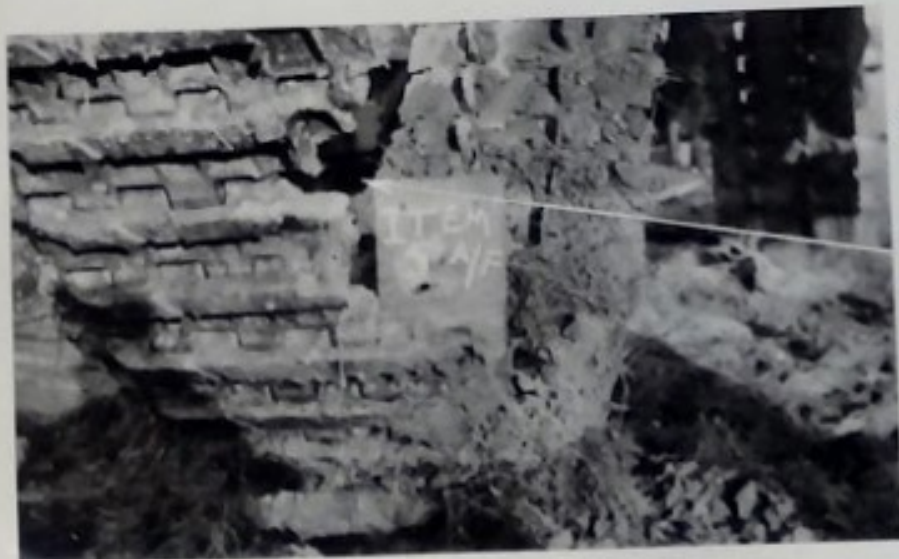
Print No. 6.

Item No. 5.  
Result from 1-Mk. V  
standard A. T. mine  
shown in Print No. 5.  
Note:-  
Track metal sheared  
out. Hull intact.

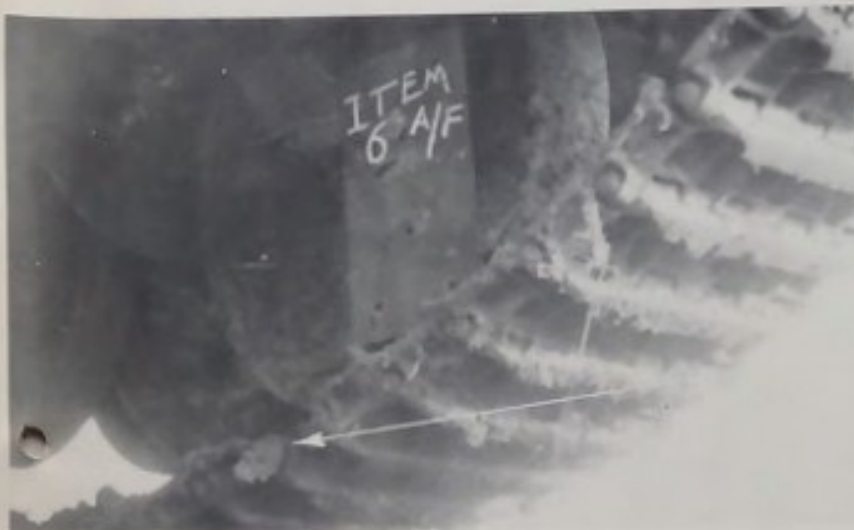
Print No. 7.

Item 6 was a repeat of item 5 but on the opposite side of the vehicle. The track inner edge damage, was less severe than for item 5 and the hull to floor plate structure remained intact.

Item No. 6.  
Result from 1-Mk. V  
standard A. T. mine  
under inner edge of  
right-hand track  
and in line with  
No. 8 bogie.

Note:-  
Small area of track  
removed. Hull  
intact.

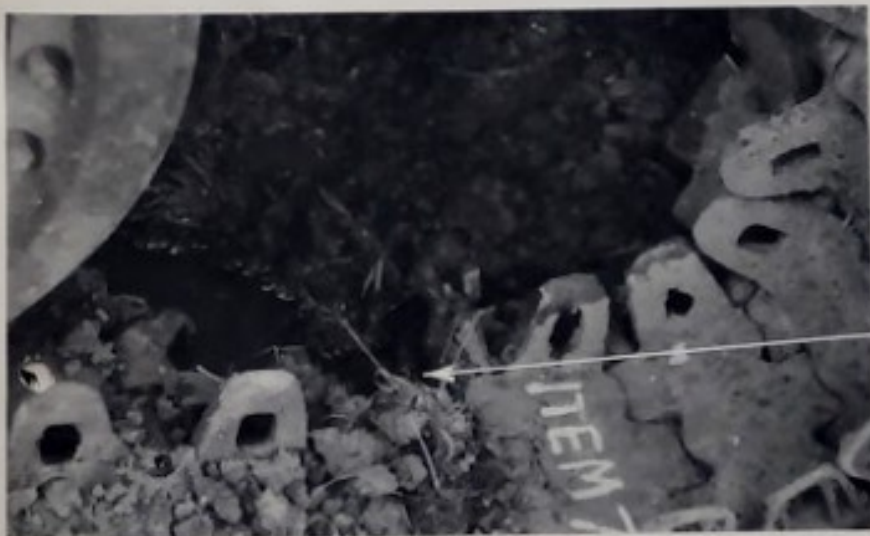
Print No. 8.

Item 7. was a further test similar to item 4 but with the mine in line with No. 3. bogie R.H. side. The track damage was comparable to item 4. The hull structure was unaffected.

<p><u>Tank No. 3041</u> <u>Item No. 7.</u> Under inner edge of R.H. track in line with No. 3 bogie (closed flange wheels) Distance from top of mine to underside belly plate 23". Hull side wall 2" away from inner edge track.</p>	<p>One Mk. V Standard A.T. Mine placed with centre of mine 2" below and in line with inner edge of track. Mine filled T.N.T. (8-lb) with No. 33 electric detonator and two C.E. (1-oz) field primers.</p>	<p>Crater 4' x 3' 6" x 18" deep with main area towards centre of vehicle. Track link sheared over area 12" x 6" wide. Field repairs to track would be possible. Hull floor and side plate intact.</p>

Item No. 7.  
Result from 1-Mk. V  
standard A. T. mine  
under inner edge of  
right-hand track  
and in line with  
No. 3 bogie.

Note:-  
Track metal sheared  
out. Hull intact.

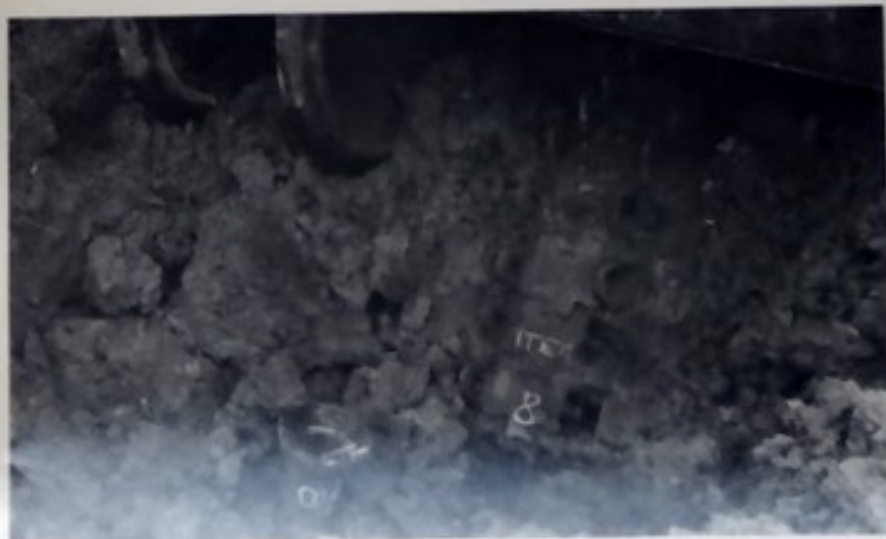
Print No. 9.

Item No. 8.  
Result from 1-5½ lb.  
asbestos cement  
mine under centre  
of left-hand track  
and in line with  
No. 2 bogie.

Note:-  
Broken track and  
other debris lying  
in crater.

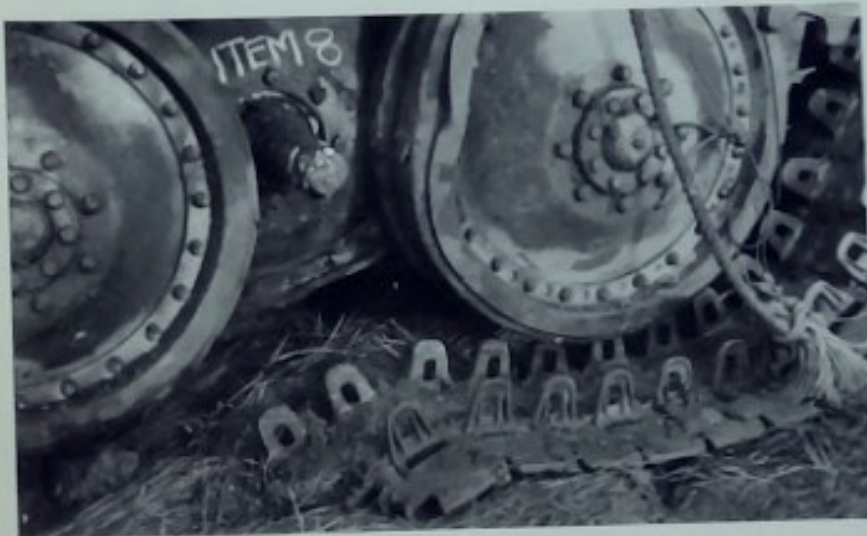
Print No.10.

Further view of  
Item 8.  
Picture taken after  
tank was placed on  
fresh site.

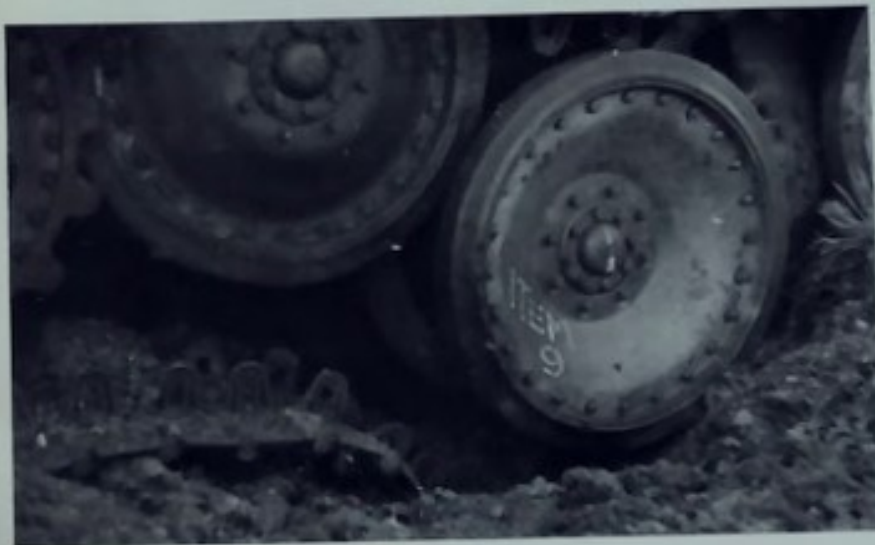
Print No.11.

Item No.9.  
Result from 1-5½ lb.  
asbestos cement  
mine under inner  
edge of left-hand  
track and in line  
with No.2 bogie.  
Note:-  
Small area of track  
removed. Hull  
intact.

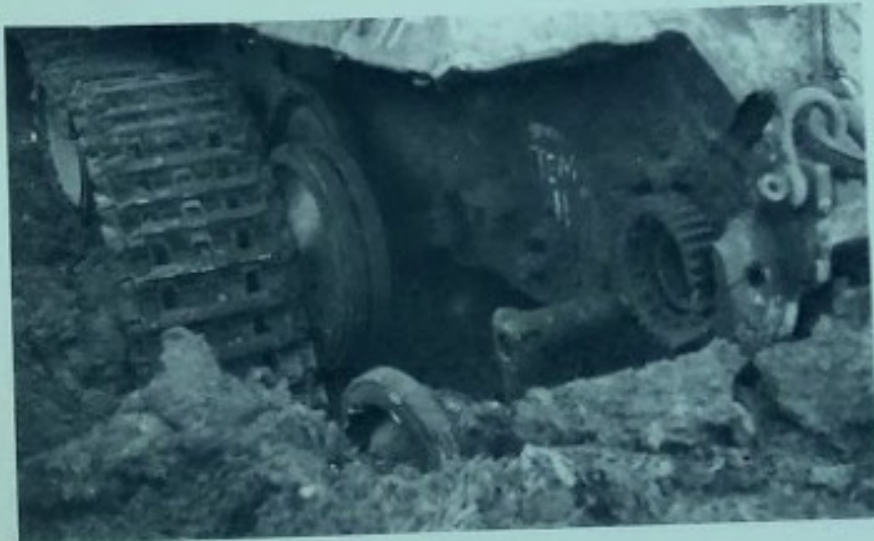
Print No.13.

One experimental 15 lb. mine (15 lb. T.N.T.) failed to detonate and was destroyed by a slab of gun cotton. The track was broken, and the leading bogie and shaft forced out of position approximately 9".

The final drive sprocket with a length of track, damaged severely in a previous trial was completely forced off and thrown clear of the vehicle.

Item No.11.  
Result from 1-15 lb.  
mine under inner  
edge of right-hand  
track and in line  
with No.1 bogie.

Note:-  
Track completely  
broken. Hull  
intact.

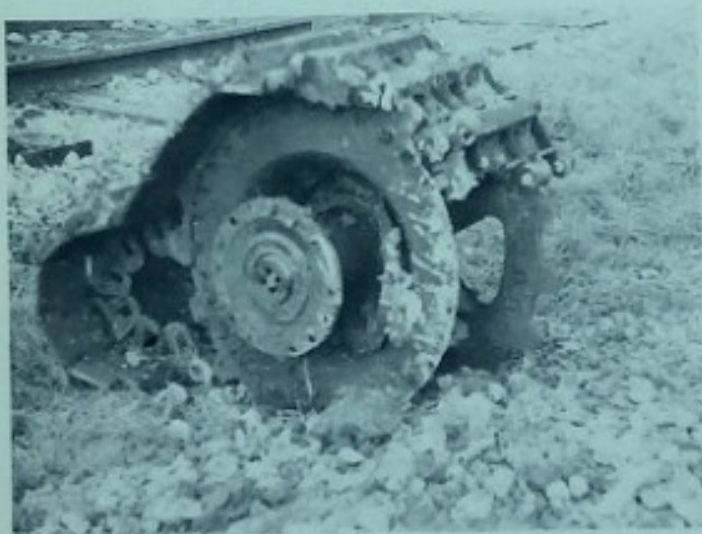
Print No.14.

Showing right-hand sprocket  
and spindle, together with  
length of track, removed by  
15 lb. mine (Item 11).

Note:-  
The final drive casting had  
been very severely cracked  
during a previous trial.

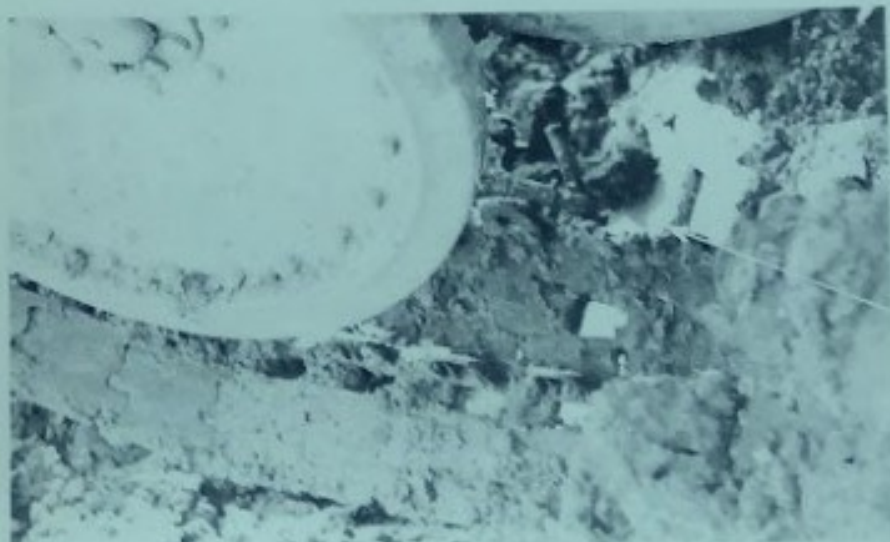
Print No.15.

This mine failed to break the track, but sheared out track metal from the inner edge 12" long x 6" wide. No. 8 bogie inner flange was partially blown away and the outer flange buckled. The bogie shaft was also forced outwards 4".

12	Under inner edge of track.	1-15 lb. mine.	Track partially severed. No. 8 bogie - inner flange partially blown away. Minor damage to hull floor locally.	Field repairs improbable.

Item No.12.  
Result from 1-15 lb.  
mine under inner  
edge of right-hand  
track and in line  
with No.9 bogie.

A field repair in this instance was considered doubtful.

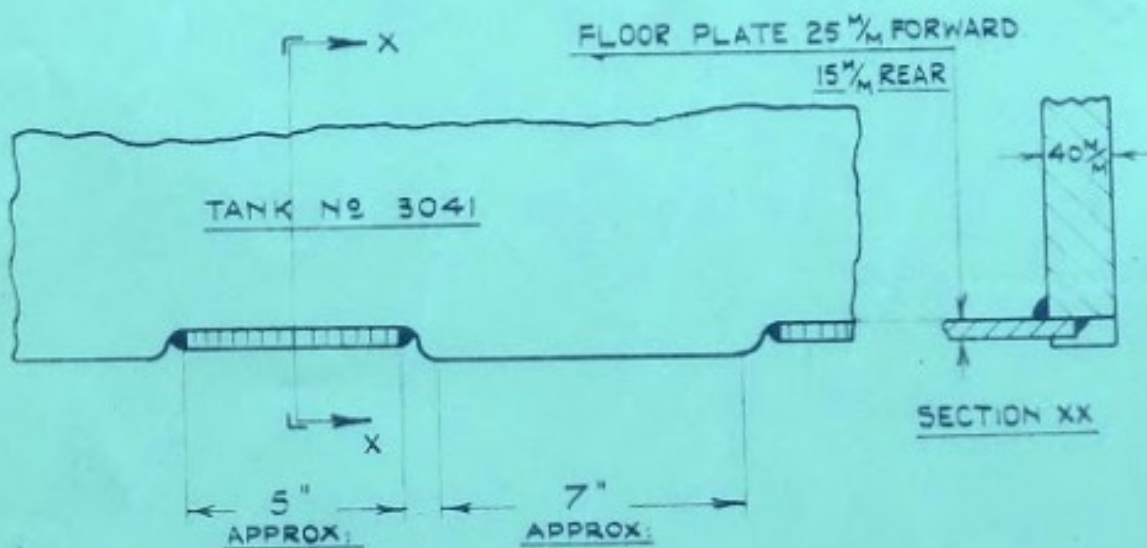
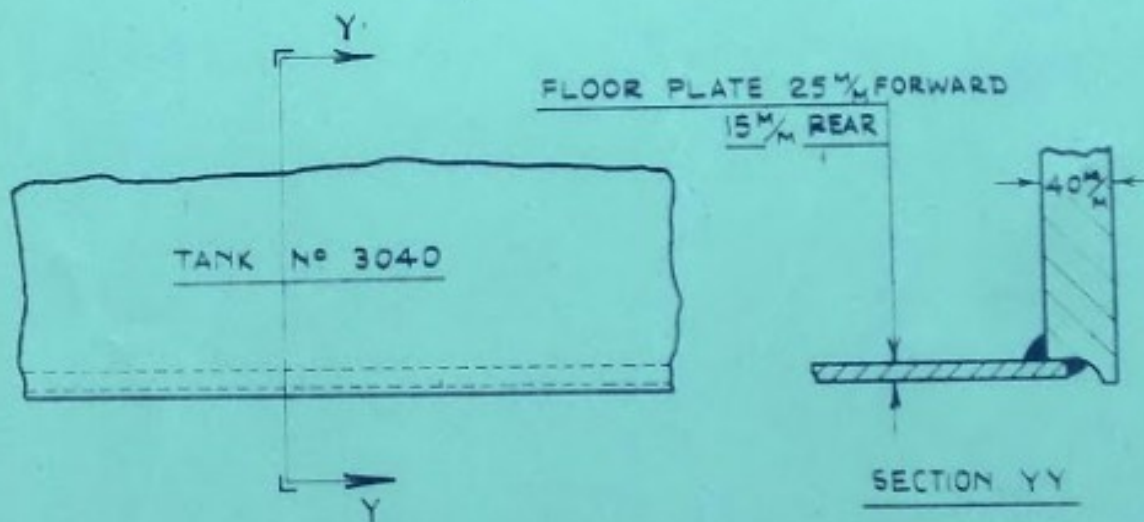
APPENDIX. C.  
SHEET. N° 1

A. T. N° 232 PART. IV  
PANTHER PZ.KW V  
DETAILS OF "SIDE WALL TO  
FLOOR" WELDED JOINT.
